Investigation of a Lineament that Might Mark the Ground-Surface Trace of the
Dog Valley Fault, Truckee Area, Northern California

A Thesis Submitted to the Faculty of
Baylor University
In Partial Fulfillment of the
Requirements for the Degree of
Bachelor of Science in Geology

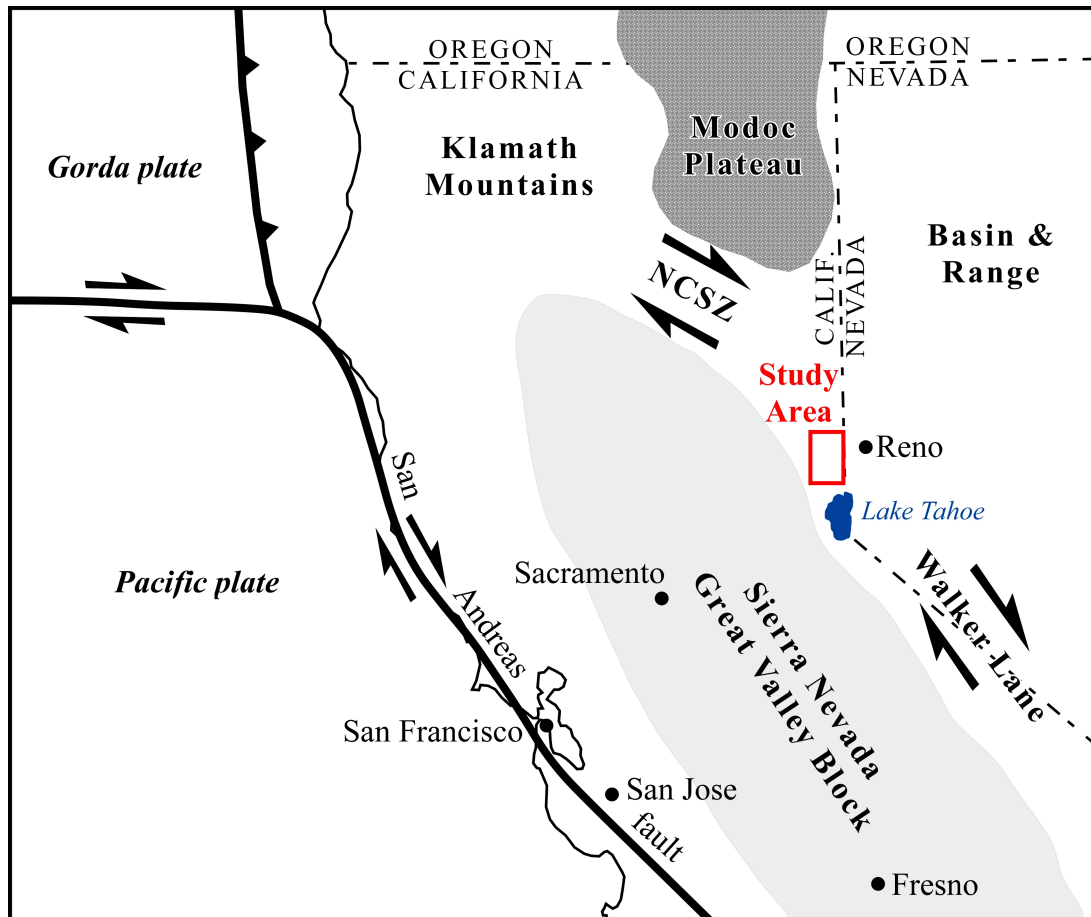
Figure 1. Location of study area (red box) within the regional tectonic context. NCSZ=Northern California Shear Zone. After Lindsay (2011).

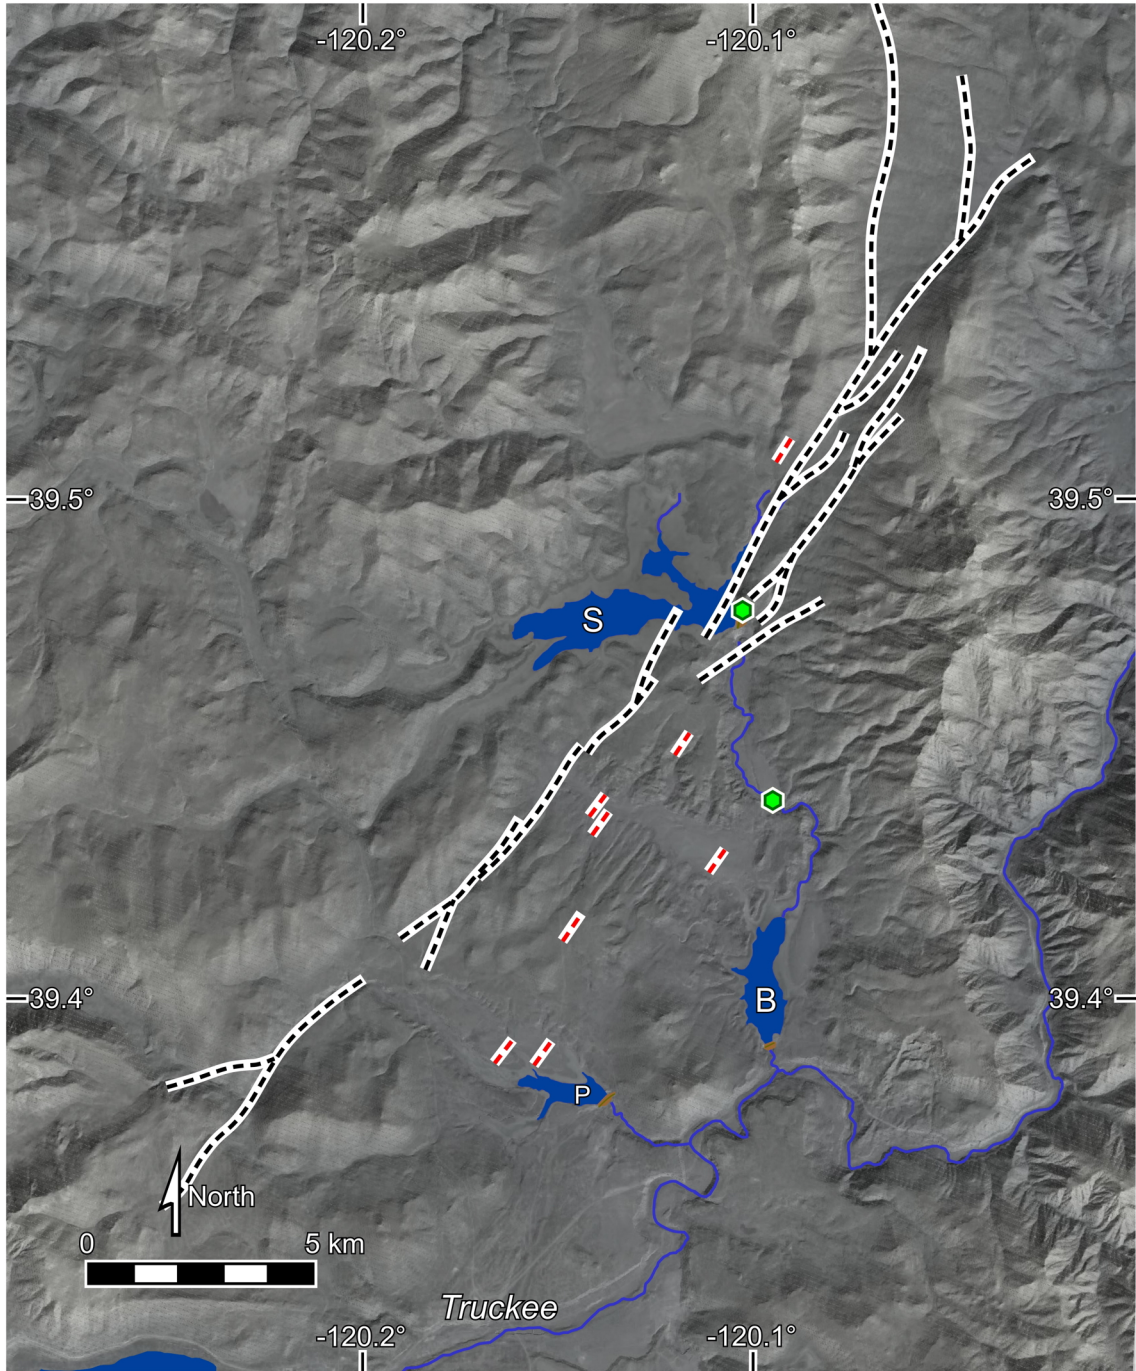
Figure 3. Trace of Dog Valley fault (black dashed curves) from the Quaternary Fault and Fold Database of the United States (USGS, 2015, after Hawkins and others, 1986, p. 66). Red dashed lines indicate locations of ground ruptures reported after the 1966 Truckee earthquake. Green hexagons are faults observed in outcrop. S=Stampede Reservoir; B=Boca Reservoir, P=Prosser Creek Reservoir.

and Fold Database of the United States (<http://earthquake.usgs.gov/hazards/qfaults/>; Olig and others, 2005; Grose, 2000). This is the current understanding of the location of the Dog Valley fault (fig. 3; *e.g.*, Olig and others, 2005).

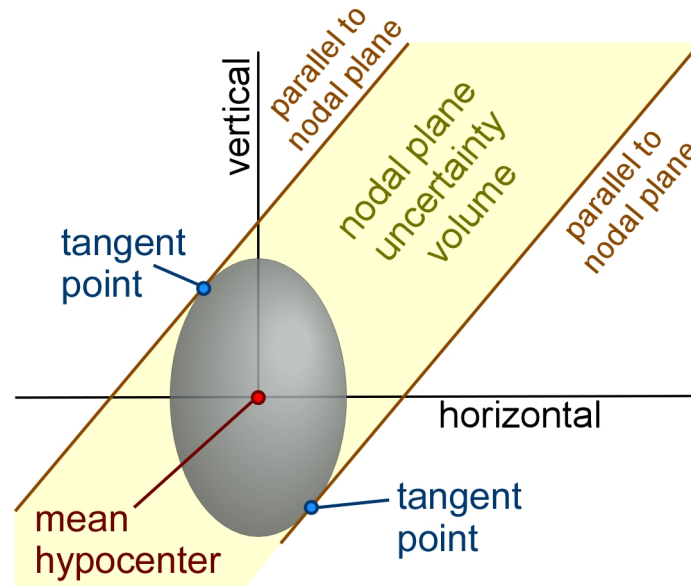
Figure 5. Cross section illustrating how the nodal plane uncertainty volume is defined in cases where the hypocenter uncertainty is known but the orientation uncertainty of the nodal plane is not known. After Lindsay (2011).

The construction of the seismo-lineament can be visualized by starting with the mean orientation of a nodal plane and the mean hypocenter (fig. 5). If no uncertainty is specified for the hypocenter or for the nodal plane, the seismo-lineament would simply be the curve formed by the intersection of the ground surface (defined by the DEM) and the nodal plane as it extends upward from the hypocenter. If uncertainties in the hypocenter depth and horizontal position are given, the uncertainty region around the hypocenter will be either a sphere (if the vertical and horizontal uncertainties are equal) or an ellipsoid -- a biaxial ellipsoid if the horizontal uncertainty is the same in all directions and is different from the vertical uncertainty, or a triaxial ellipsoid if the horizontal uncertainty is elliptical. The nodal plane uncertainty volume is defined as in figure 5 for cases in which

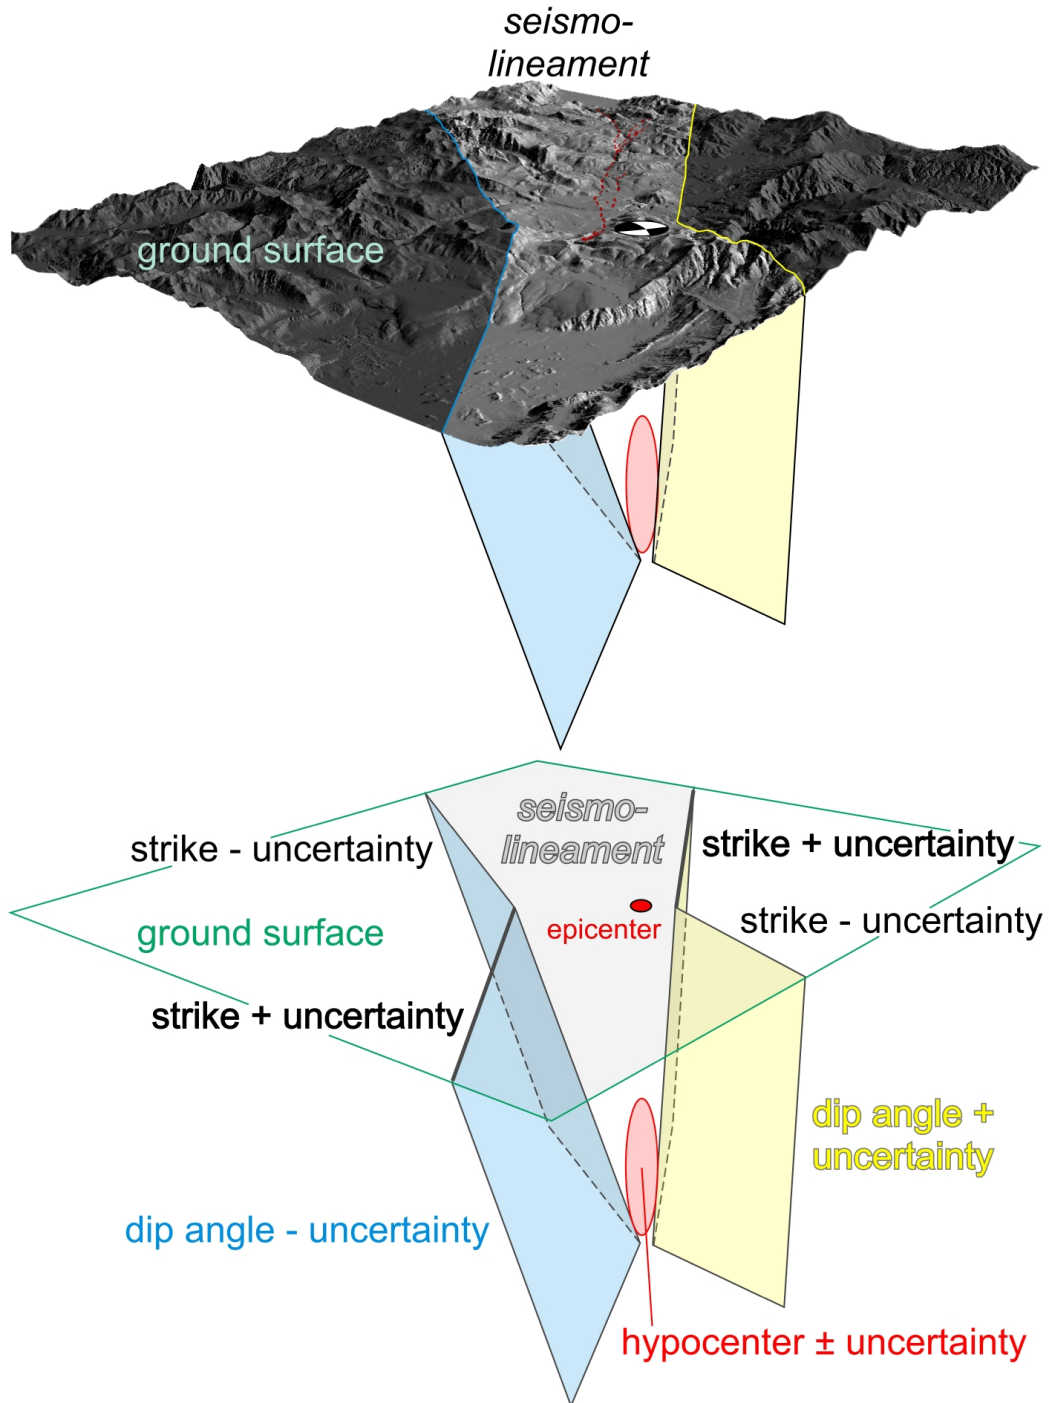
Figure 6. Top illustration shows the bow-tie-shaped seismo-lineament (light gray) for a nodal plane of the focal mechanism shown. Bottom illustration indicates the geometry of the bounding surfaces for the seismo-lineament extending from the hypocentral uncertainty ellipsoid. 2X vertical exaggeration. From Reed (2013).

the triaxial ellipsoid (fig. 6). The output of the *SLAMcode* notebook is a hillshade map with the seismo-lineament boundaries (fig. 7; also see appendix figs. A1-A13).

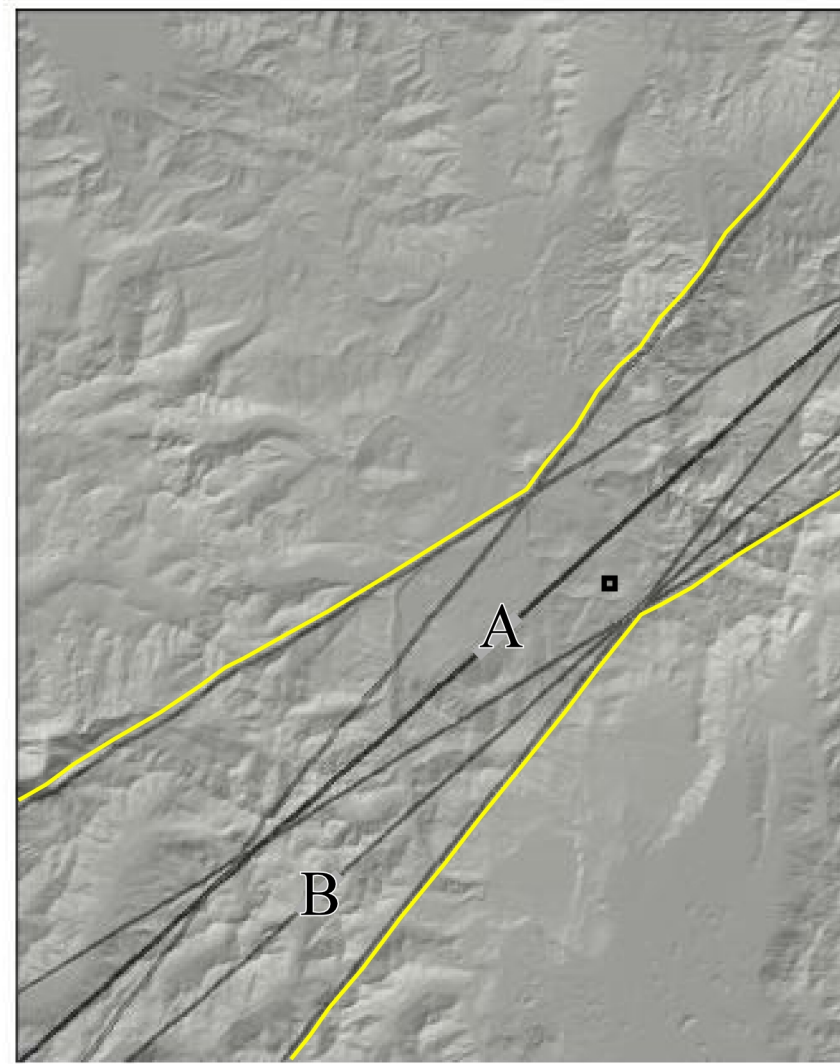
Figure 7. Annotated raw output from the SLAM code for the NE-striking nodal plane of an earthquake in the north Tahoe area. Curve A marks the ground-surface trace of the mean nodal plane. Curve B marks the trace of the nodal plane with a dip equal to the mean dip plus the dip uncertainty. Yellow curves mark the outer boundaries of all possible nodal-plane traces given the mean nodal plane orientation \pm the strike uncertainty and \pm the dip uncertainty.

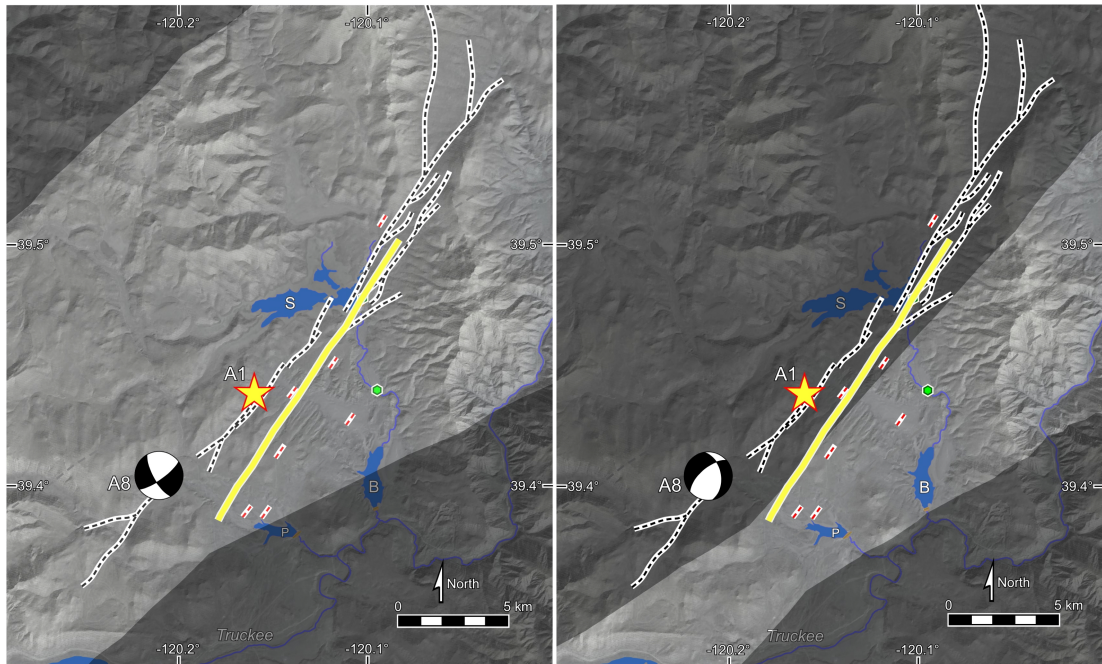
Figure 13. Hillshade images of the NE-trending seismo-lineaments (lighter gray) of the two focal mechanisms determined for the M 3.7 earthquake of 12 June 2004. Focal mechanism A8A is shown on the left map, and focal mechanism A8B is on the right map. Inferred location of the Dog Valley fault is marked by dashed black curves. Red dashed lines mark places where “broken ground” was observed after the Truckee earthquake (Kachadoorian and others, 1967), whose epicenter is marked by the star. Yellow curve is the geomorphic lineament investigated in this research.

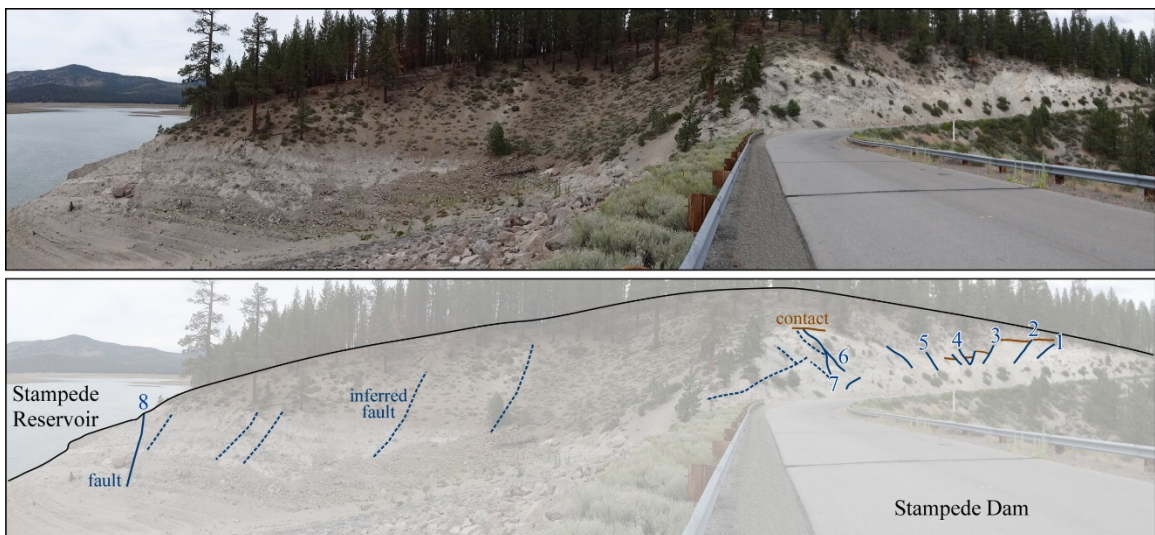
Figure 15. Panoramic overview of the faults present in the northeast abutment of the Stampede Dam. Faults to the left (west) of the road were located below the high water line of Stampede Reservoir. The road in the photograph is Dog Valley Road. Fault numbers correlate with table 5.

The first field observations were made at a south-facing roadcut along Dog Valley Road at the northeast abutment of the Stampede Dam (figs. 15-21). Nine faults were identified in the roadcut, with several showing obvious displacement. The roadcut was composed of a Miocene-Pliocene andesitic mudflow breccia containing large angular clasts up to a meter in diameter (Birkeland, 1963; Saucedo and Wagner, 1992; Saucedo, 2005). Several of the faults exhibited a change in color across the fault surface, with the footwall comprised of an overall lighter material than the hanging wall (fig. 17). Faults 1-5, along the east side of the roadcut, had cores that ranged from a few millimeters to ~12 centimeters in width (fig. 18), comprised of a moist, dark, rusty colored gouge that was infiltrated by small root networks. Due to the coarse, poorly consolidated nature of the surrounding breccia, no shear striae were observed in any of the road cut faults.

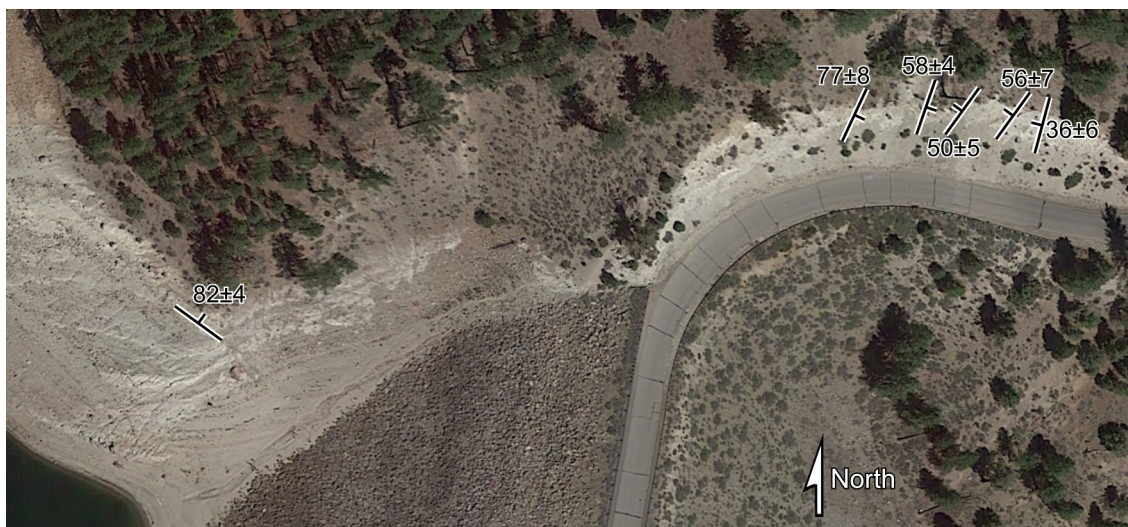
Figure 16. Aerial map view of the faults present in the northeast abutment of the Stampede Dam. The strike-and-dip symbols on the upper right corner of the image are faults 1-5, as labeled in figure 14 above. Orientation data for fault 8 is shown on the left (west) side of the image, and faults 9-11 are in that same area. The road in the image is Dog Valley Road. Image was taken 16 April 2015 and was acquired from Google Earth.

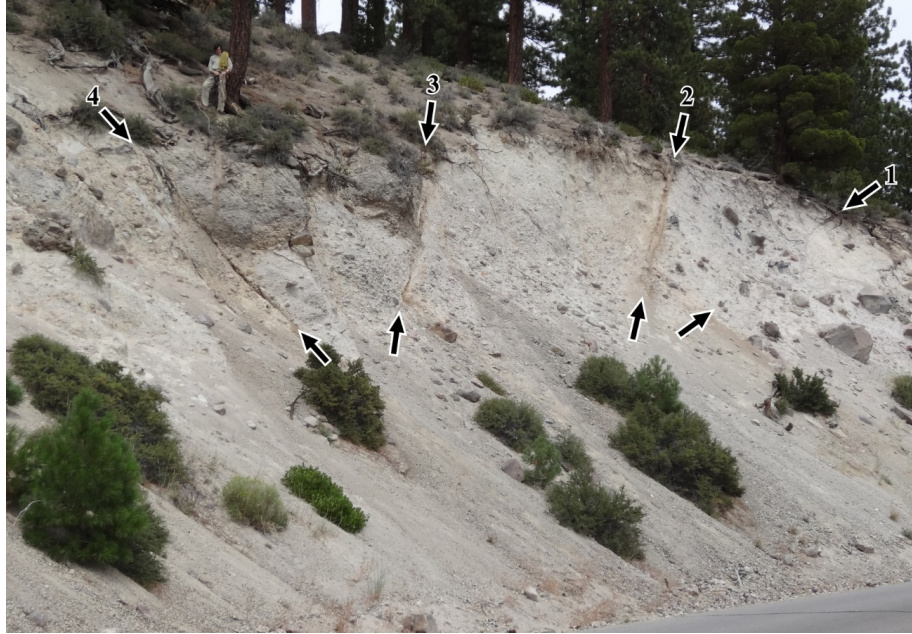
Figure 17. Prominent faults located in the eastern half of the roadcut along Dog Valley Road at the northeast abutment of the Stampede Dam. Fault numbers correlate with table 5 and figure 14.

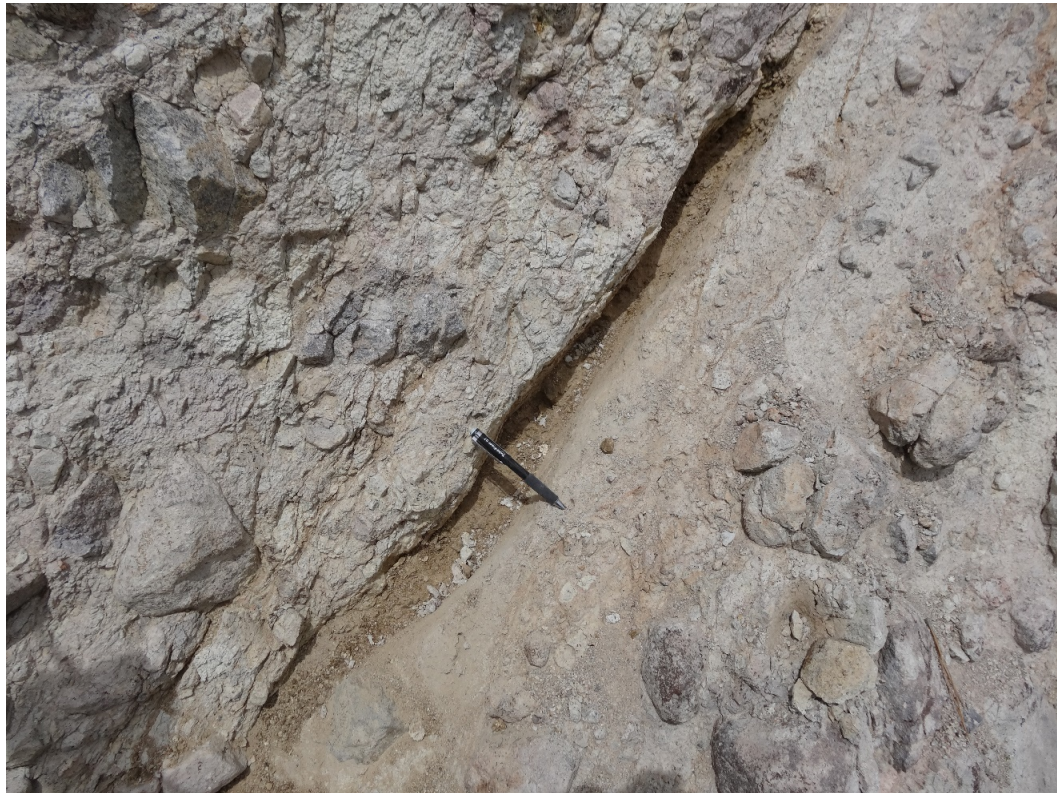
Figure 18. Photograph showing an excavated fault surface located along fault 2 exposed in the road cut along Dog Valley Road. Fault gouge zone is ~10 cm wide.

The width of the gouge zone was not consistent across all faults. Faults 6 and 7 had essentially no gouge zones that I observed. In contrast, fault 5 has a wide enough fault core to excavate and directly record strike and dip measurements with a Brunton compass. Most of the faults had no obvious markers that could be used to measure separation or slip, but faults 6 had an outcrop-parallel separation of ~86 cm and fault 7 had an outcrop-parallel separation of ~107 cm (fig. 19). The faults observed in this roadcut had strikes with an average orientation of $28^{\circ} \pm 10^{\circ}$ with dip angles between $36-56^{\circ}$ NW and $74-87^{\circ}$ SE.

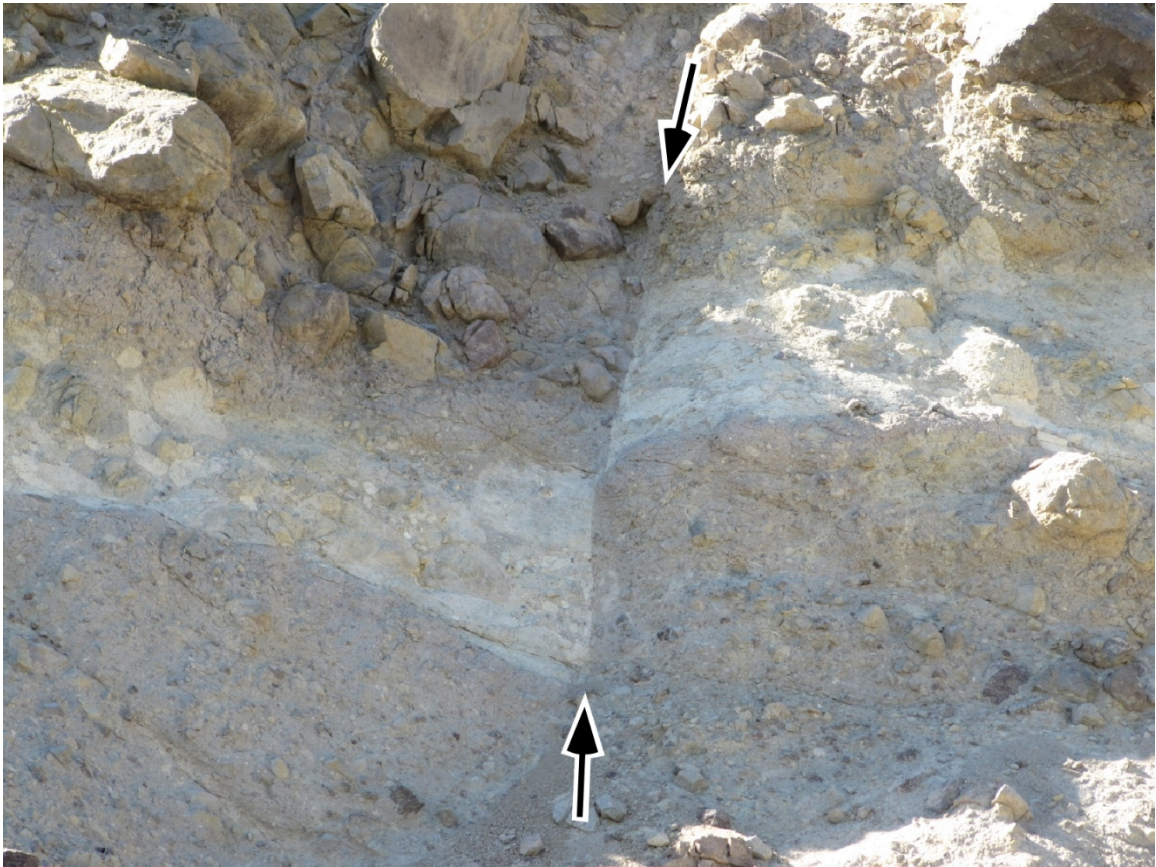
Figure 19. Photograph of separation along fault 7 exposed in the road cut along Dog Valley Road on the northeast abutment of Stampede Dam. The light colored volcanic bed is displaced ~107 cm.

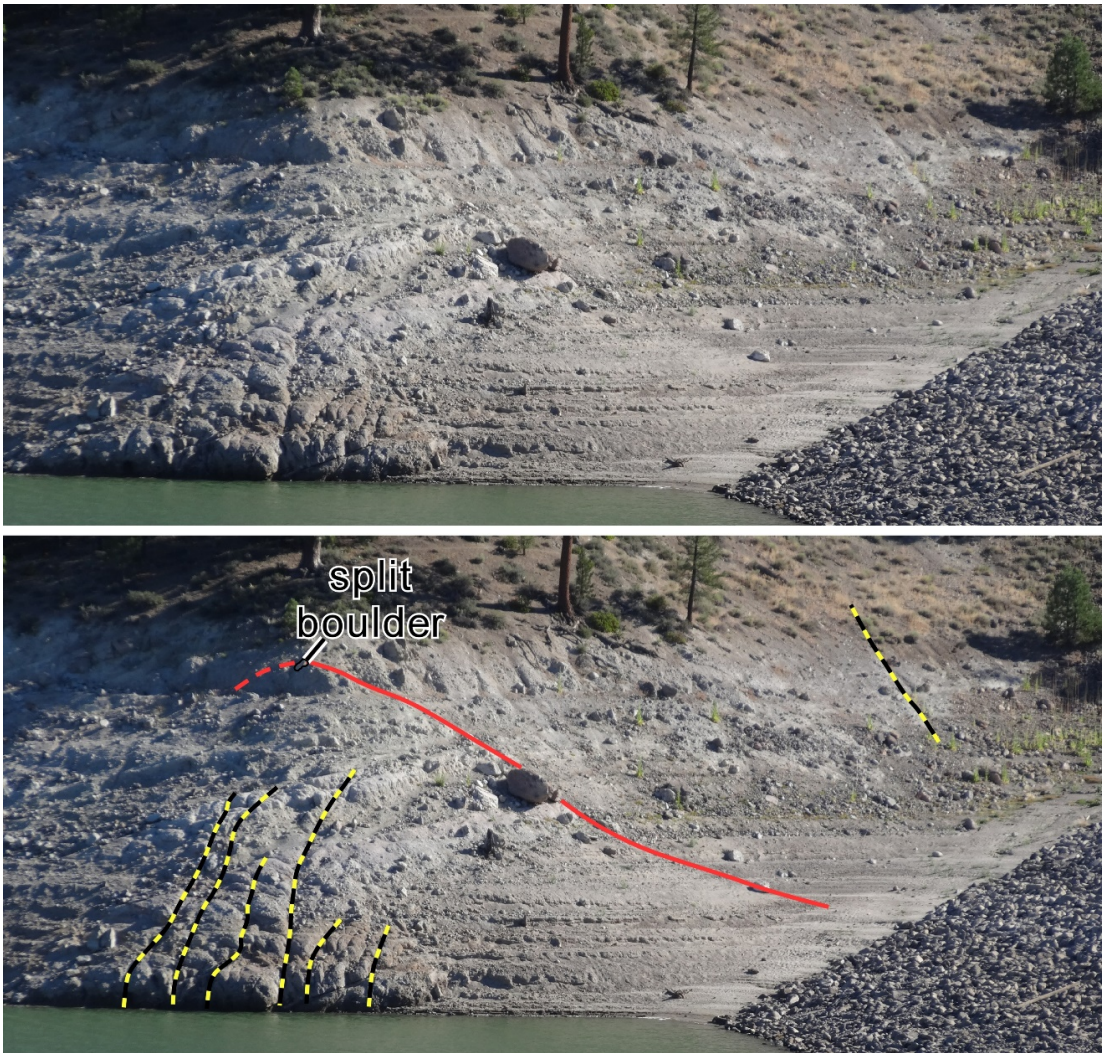
Figure 20. Photograph of fault 8 and related fractures taken from the Stampede Valley Dam looking north. Red curve is fault 8, yellow-black dashed curves are other joints or small faults. The location of the small split boulder used to obtain fault orientation data is shown.

Another set of faults was observed along the exposed shoreface of the northeast abutment of the Stampede Dam (fig. 20). This shoreface has been exposed as a result of the severe drought conditions that had persisted for more than a year prior to the field season. Observations made from Dog Valley Road suggested that there were several faults present in the hillslope that would otherwise be concealed by normal reservoir levels. The most obvious of these faults was fault 8, which had a split red boulder along

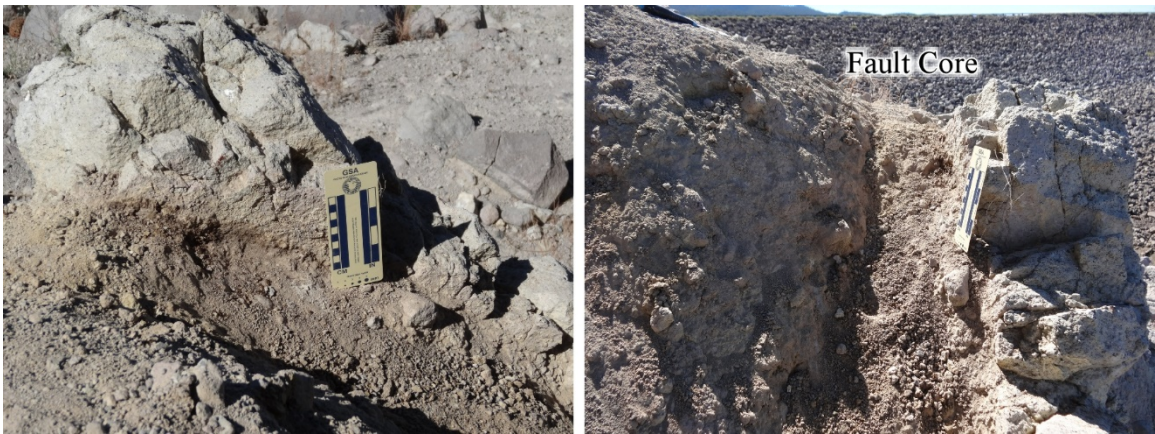
Figure 21. Photograph of the excavated fault core of fault 8. Fault core is ~15cm wide. Fault orientation data were obtained from both the excavated surface of the fault (left of center) and the face of a small split boulder (right of center).

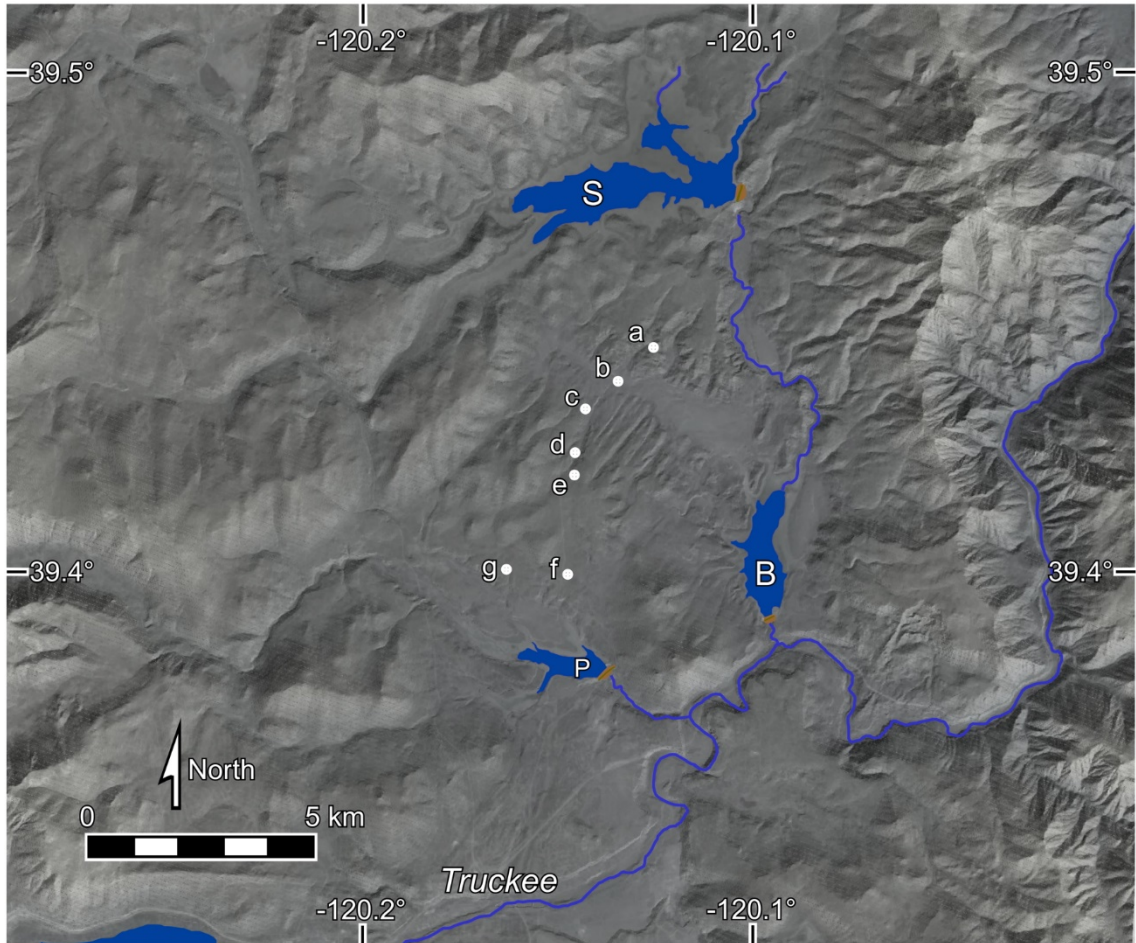
Figure 22. Locations along or adjacent to the geomorphic lineament where field observations were made. All locations are accessible by a conventional automobile.

Moving southwest from Russell Valley, the lineament was intersected again by Dog Valley Road (site c, fig. 22). At this location, a small seasonal channel, which drained into the larger channel observed from Russell Valley Road, was observed to be in rough orientation with the lineament. Like the previous location, no physical evidence of exposed faults was observed.

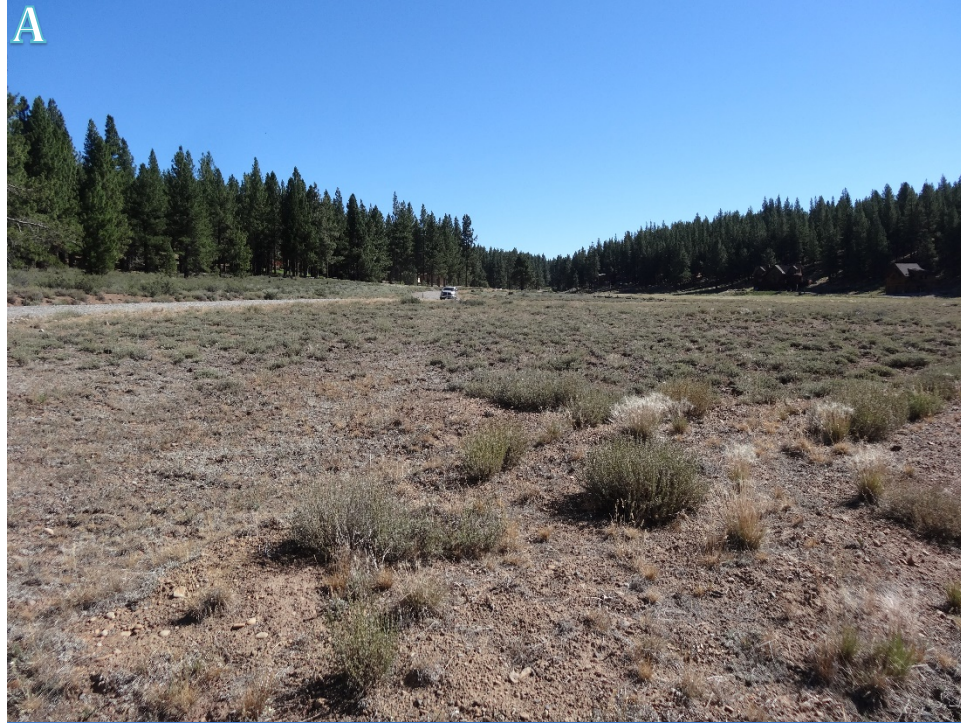
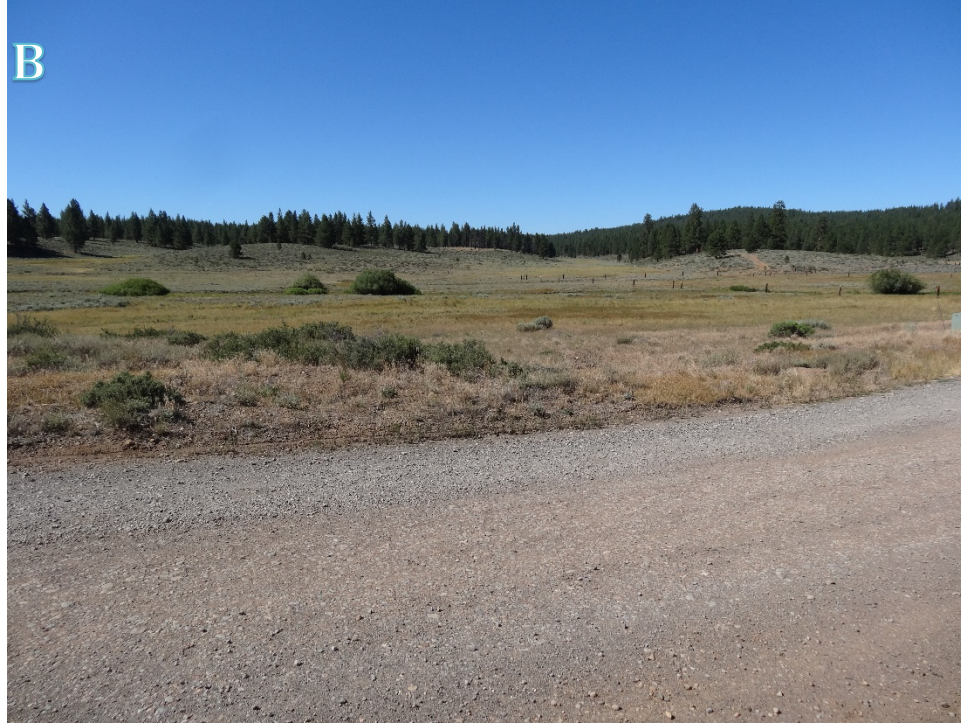
Figure 23. Photographs taken from site b on Russell Valley Road. Photograph A is looking northeast up the lineament along Greenlee Road. Photograph B is looking southwest along the seismo-lineament.

reach from Russell Valley Road. The orientation of the two channels was recorded with a Brunton compass, and found to be consistent with the orientation of the lineament. No physical evidence of exposed faults was observed at these locations, likely due to the presence of thick soil and glacial sediments and heavily wooded nature of the area.

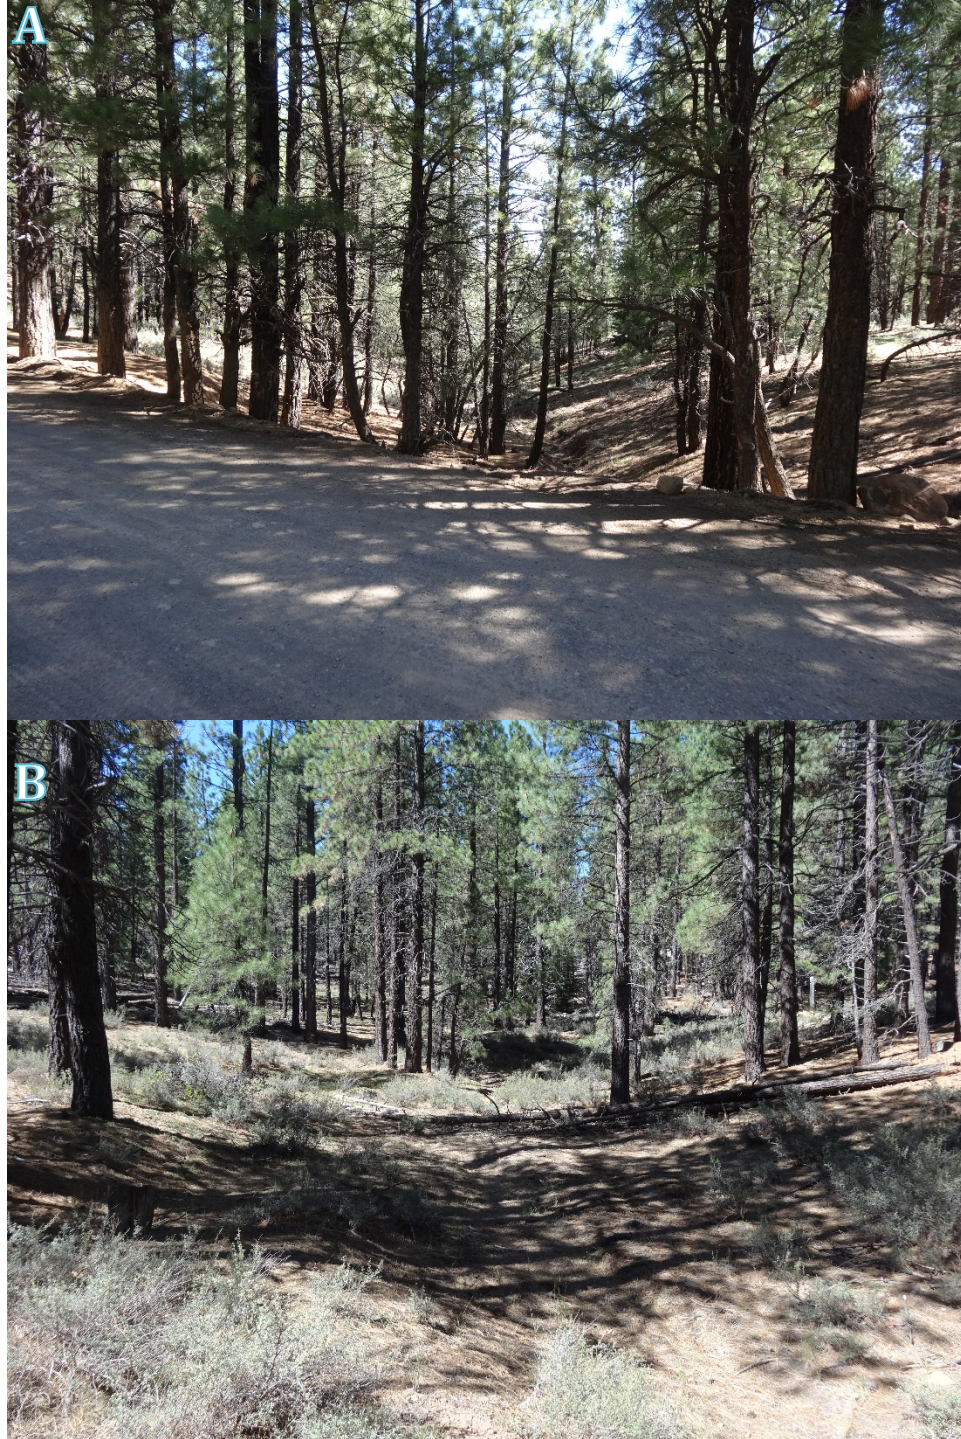
Figure 24. Photographs looking up and down the lineament from its intersection with Dog Valley Road at site c. Picture A is looking northeast along the lineament. Picture B is looking southwest along the lineament.

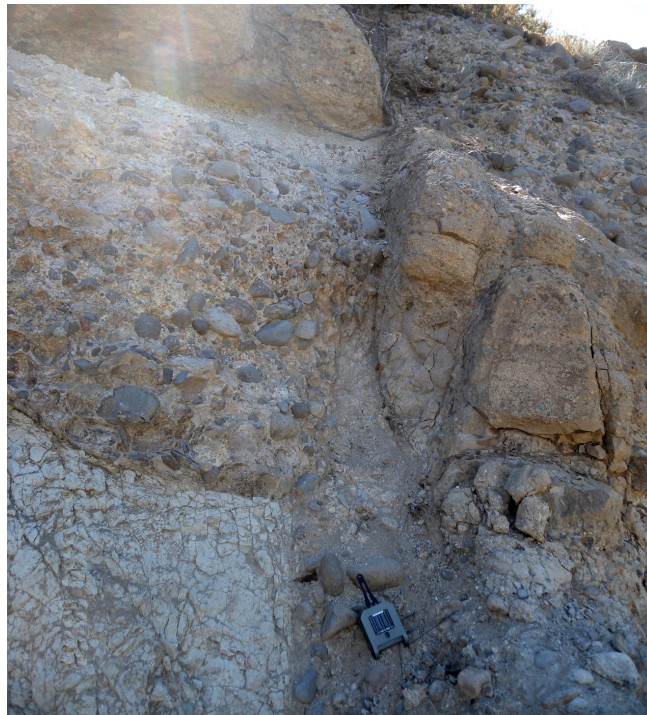
Figure 2. Fault observed along the Little Truckee River approximately 5 kilometers southwest of the Stampede Dam. This fault did not fall within the seismo-lineament assessed for this field data, but is consistent with ground surface ruptures observed following the 1966 M 6.0 earthquake. Photographed by Ryan Lindsay *circa* 2010.

While exposed faults were only present along the lineament at one location, another exposed fault was observed within the general area. Approximately four kilometers south of the Stampede Dam, a fault is visible in an outcrop on a small cliff face southwest of the Little Truckee River (more southerly green hexagon in fig. 9). This fault was previously examined by Kachadoorian and others (1967) and Lindsay (2011). It did not have any obvious displacement during the 1966 M 6.0 earthquake and was not located along the lineament I investigated, so I make note of it here merely as a candidate for investigation in future studies.

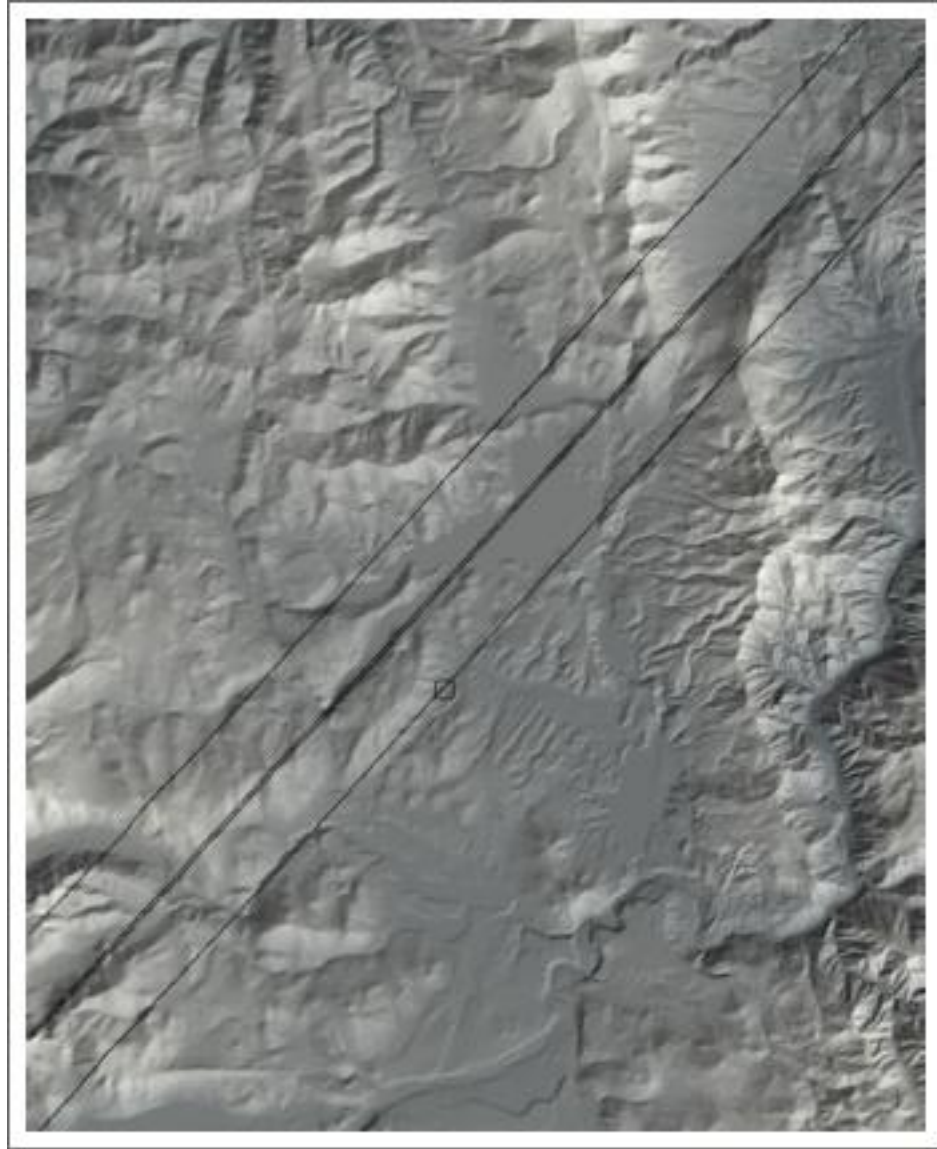
Figure A1. Raw output of *SLAMcode.nb* for earthquake A1 on 12 September 1966. Small square marks the epicenter at latitude 39.438°N longitude 120.160°W . Nodal plane dip direction is 134° , dip angle 80° , rake 180° . Hypocenter depth was 10 km. The curves indicate the extent of the seismo-lineament. The image is aligned with the UTM grid, so the image would have to be rotated $\sim 1.73^{\circ}$ clockwise to be aligned with the geographic coordinate system at/near its center. North is toward the top of the page.

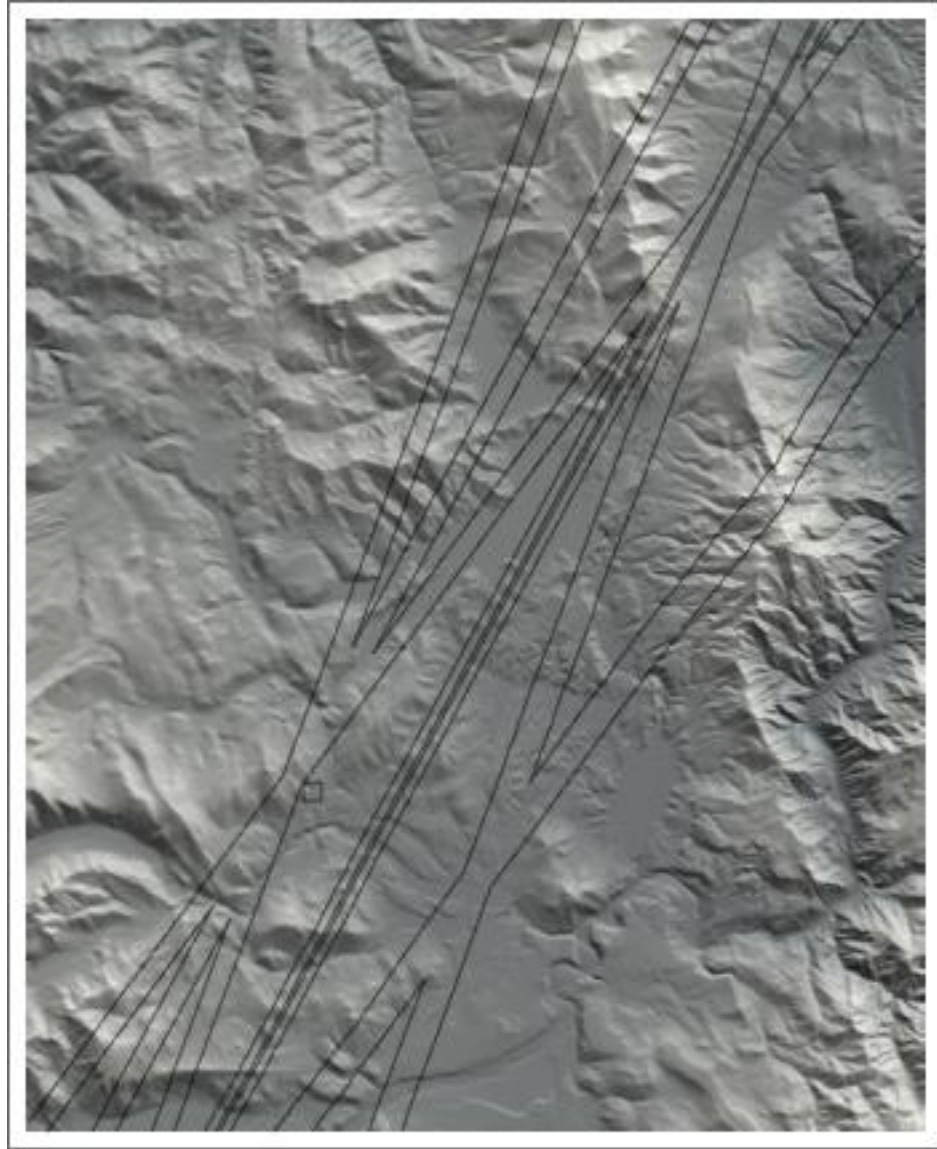
Figure A2. Raw output of *SLAMcode.nb* for earthquake A2 on 3 July 1983. Small square marks the epicenter at latitude 39.412°N longitude 120.206°W . Nodal plane dip direction is 300° , dip angle 80° , rake 20° . Hypocenter depth was 11.05 km. The curves indicate the extent of the seismo-lineament. The image is aligned with the UTM grid, so the image would have to be rotated $\sim 1.73^{\circ}$ clockwise to be aligned with the geographic coordinate system at/near its center. North is toward the top of the page.

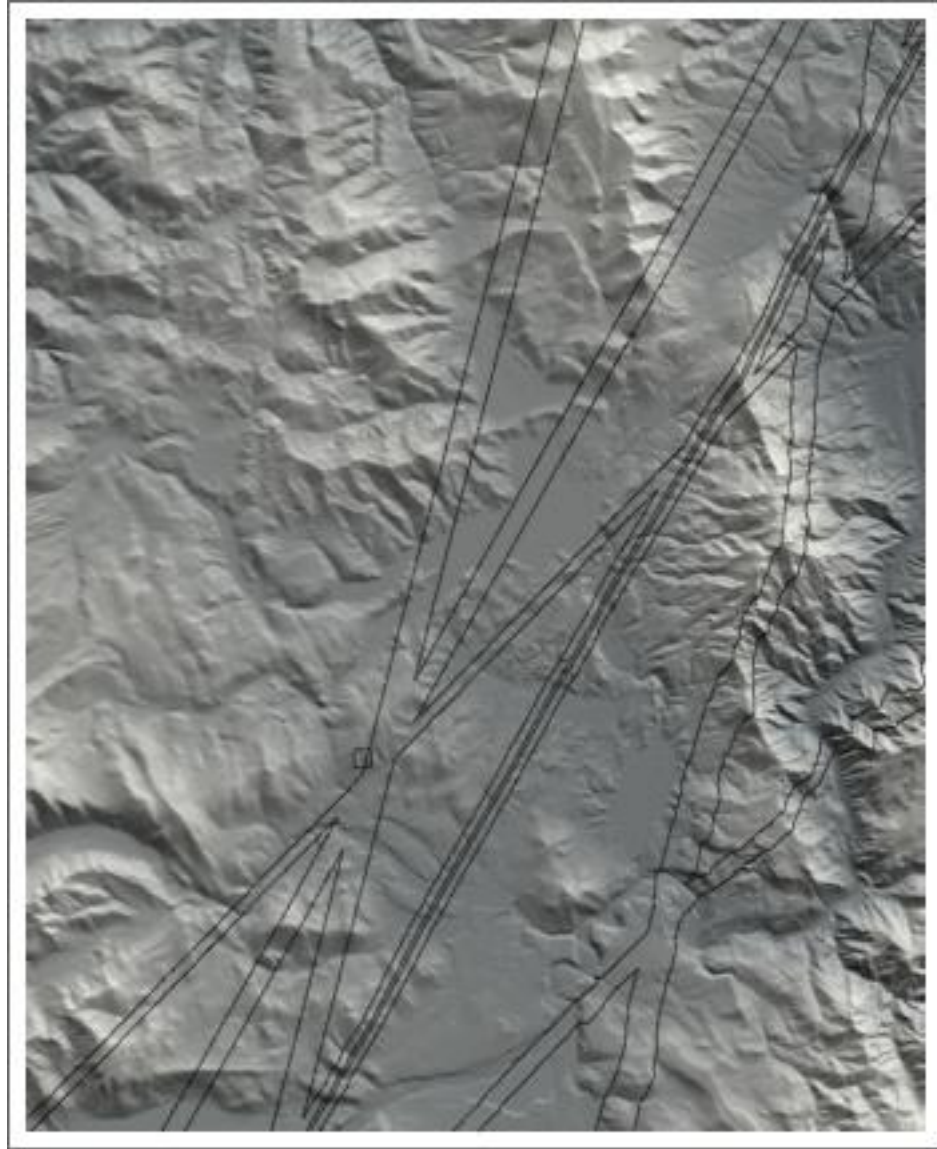
Figure A3. Raw output of *SLAMcode.nb* for earthquake A3 on 30 August 1992. Small square marks the epicenter at latitude 39.42047°N longitude $120.18852^{\circ}\text{W}$. Nodal plane dip direction is 301° , dip angle 61° , rake 12° . Hypocenter depth was 5.34 km. The curves indicate the extent of the seismo-lineament. The image is aligned with the UTM grid, so the image would have to be rotated $\sim 1.73^{\circ}$ clockwise to be aligned with the geographic coordinate system at/near its center. North is toward the top of the page.
