Investigation of a Lineament that Might Mark the Ground-Surface Trace of the
Dog Valley Fault, Truckee Area, Northern California

A Thesis Submitted to the Faculty of
Baylor University
In Partial Fulfillment of the
Requirements for the Degree of
Bachelor of Science in Geology

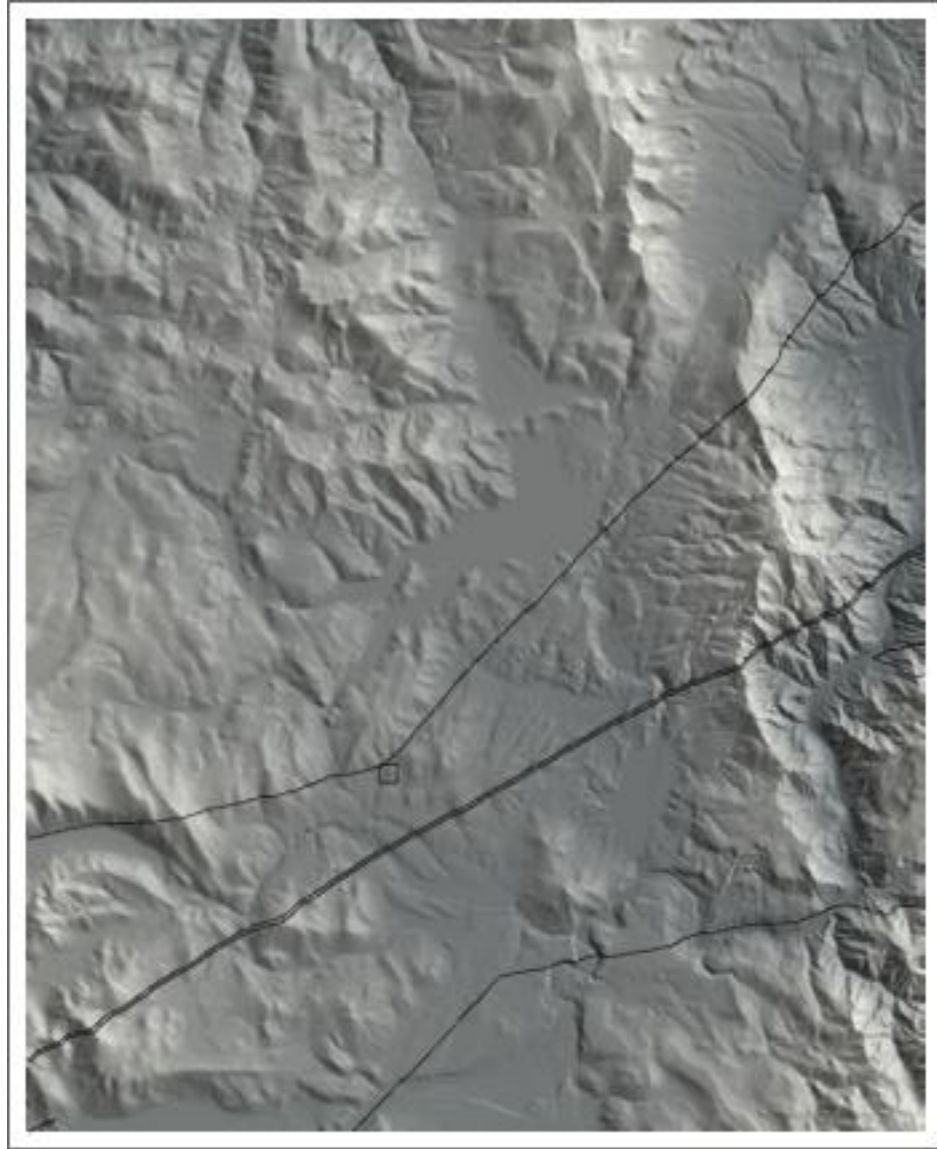
Figure A4. Raw output of *SLAMcode.nb* for earthquake A4 on 6 August 1993. Small square marks the epicenter at latitude 39.41621°N longitude $120.18018^{\circ}\text{W}$. Nodal plane dip direction is 333° , dip angle 48° , rake 59° . Hypocenter depth was 0.368 km. The curves indicate the extent of the seismo-lineament. The image is aligned with the UTM grid, so the image would have to be rotated $\sim 1.73^{\circ}$ clockwise to be aligned with the geographic coordinate system at/near its center. North is toward the top of the page.

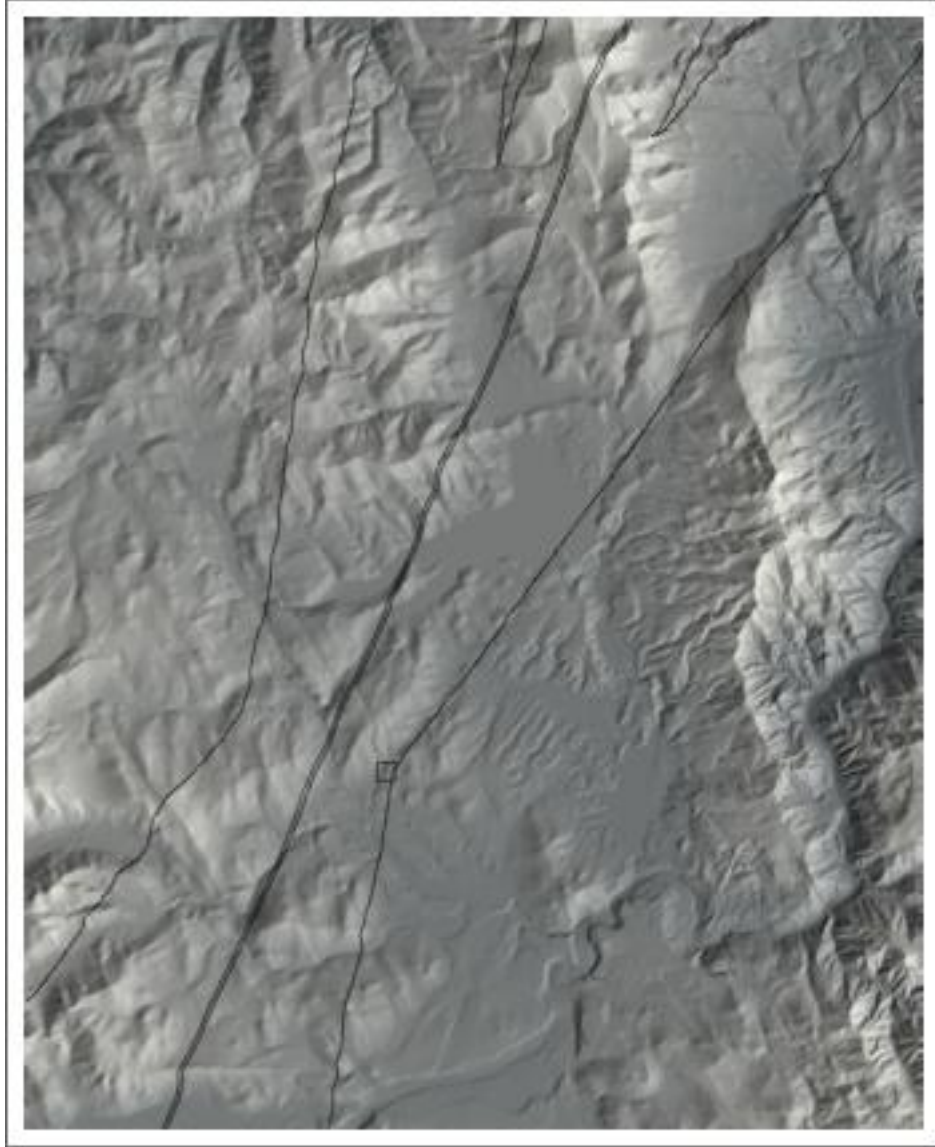
Figure A5. Raw output of *SLAMcode.nb* for earthquake A4 on 6 August 1993. Small square marks the epicenter at latitude 39.41621°N longitude $120.18018^{\circ}\text{W}$. Nodal plane dip direction is 115° , dip angle 50° , rake -70° . Hypocenter depth was 0.368 km. The curves indicate the extent of the seismo-lineament. The image is aligned with the UTM grid, so the image would have to be rotated $\sim 1.73^{\circ}$ clockwise to be aligned with the geographic coordinate system at/near its center. North is toward the top of the page.

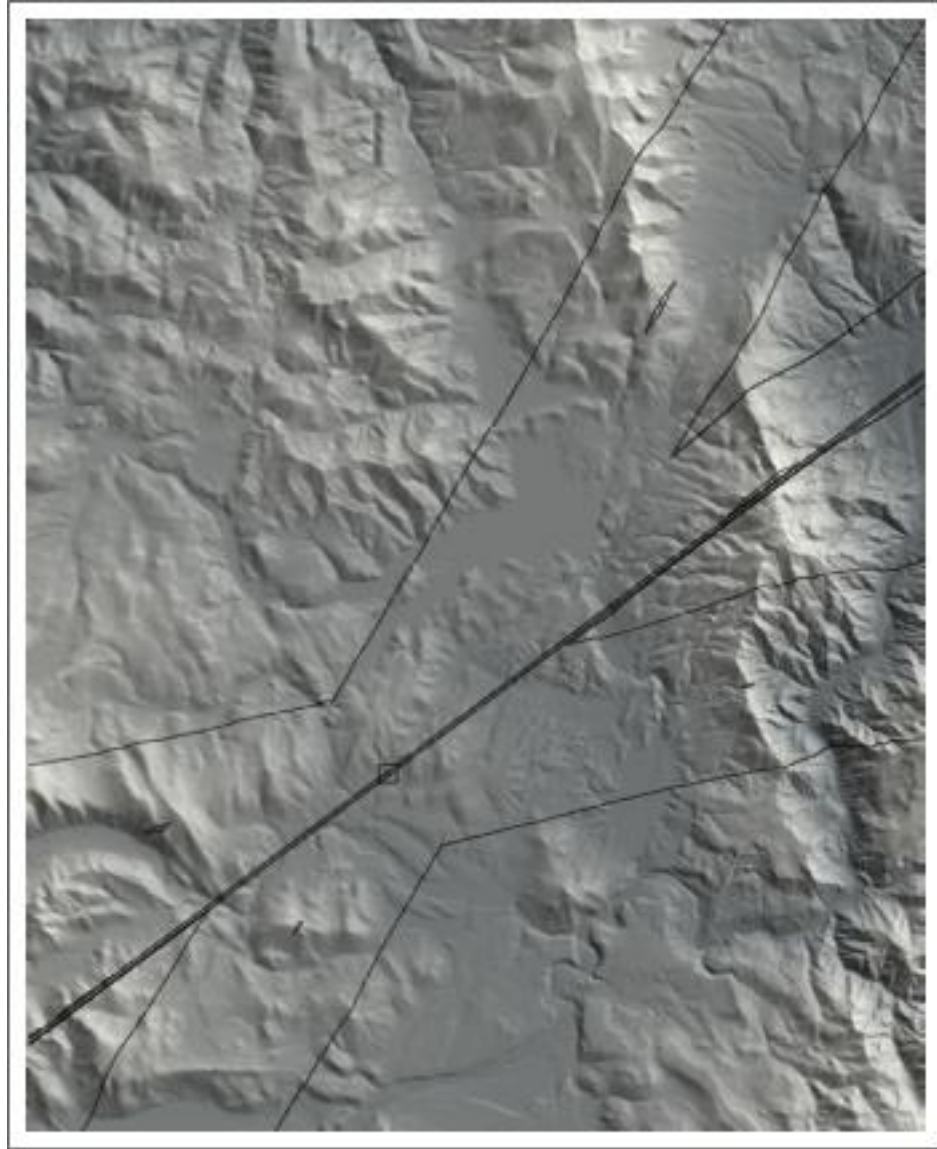
Figure A6. Raw output of *SLAMcode.nb* for earthquake A4 on 6 August 1993. Small square marks the epicenter at latitude 39.41621°N longitude $120.18018^{\circ}\text{W}$. Nodal plane dip direction is 325° , dip angle 90° , rake 30° . Hypocenter depth was 0.368 km. The curves indicate the extent of the seismo-lineament. The image is aligned with the UTM grid, so the image would have to be rotated $\sim 1.73^{\circ}$ clockwise to be aligned with the geographic coordinate system at/near its center. North is toward the top of the page.

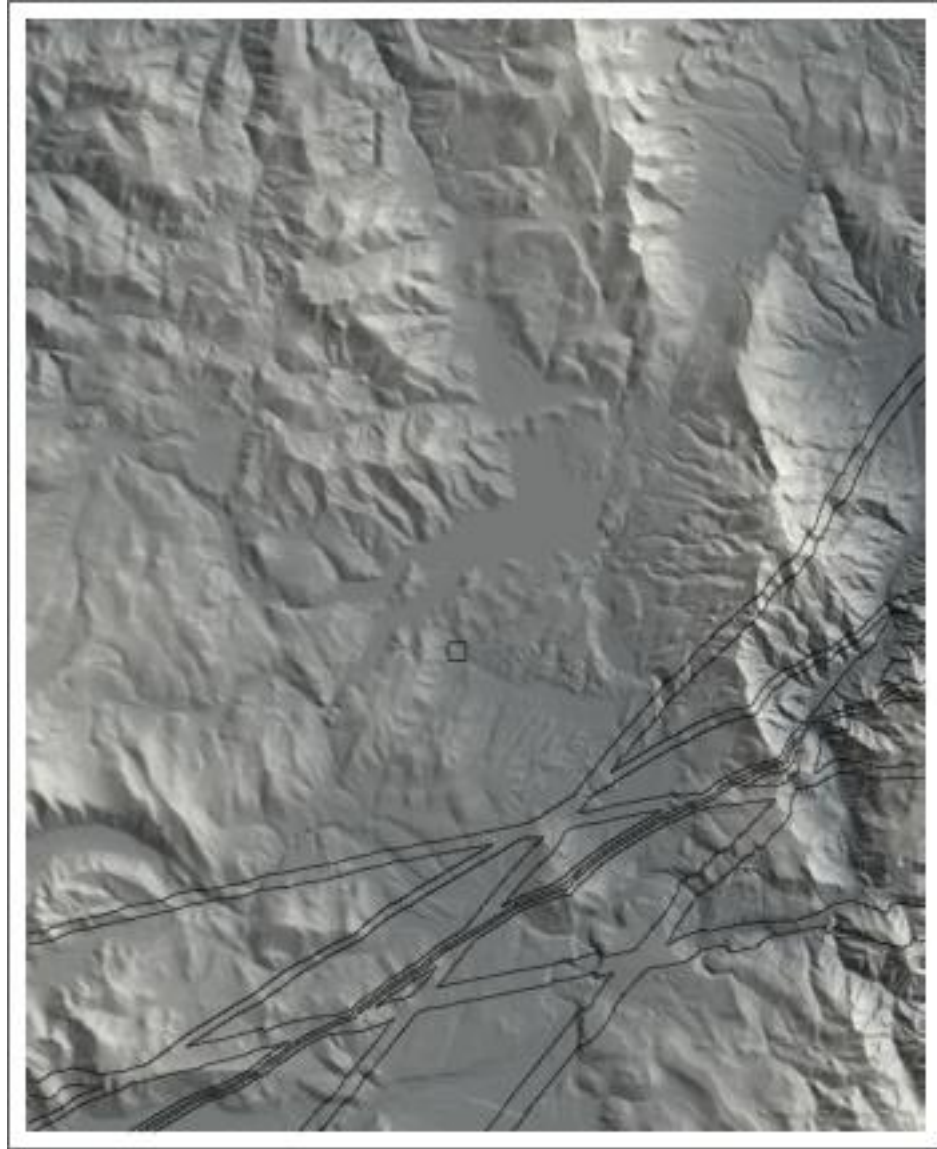
Figure A7. Raw output of *SLAMcode.nb* for earthquake A5 on 15 January 1998. Small square marks the epicenter at latitude 39.44810°N longitude $120.15511^{\circ}\text{W}$. Nodal plane dip direction is 331° , dip angle 41° , rake 49° . Hypocenter depth was 4.636 km. The curves indicate the extent of the seismo-lineament. The image is aligned with the UTM grid, so the image would have to be rotated $\sim 1.73^{\circ}$ clockwise to be aligned with the geographic coordinate system at/near its center. North is toward the top of the page.

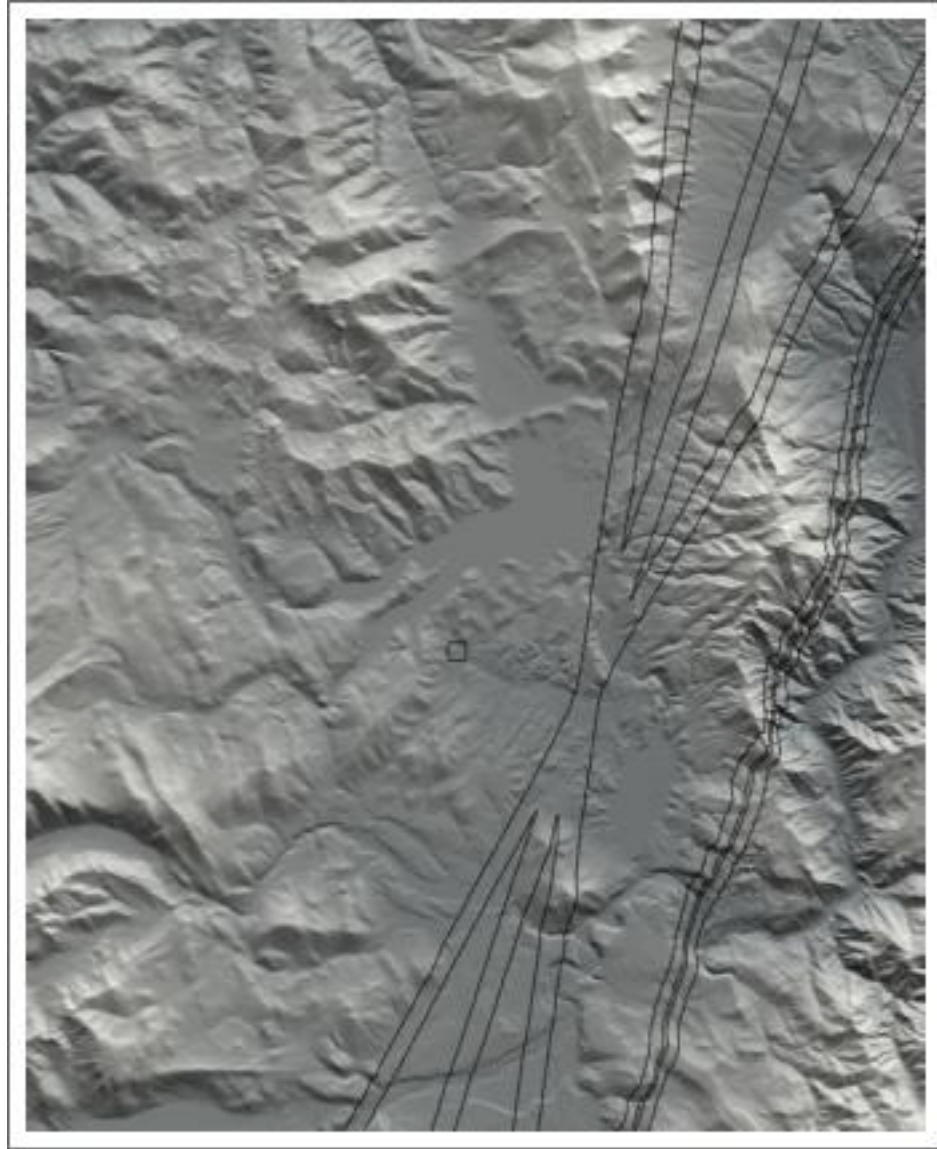
Figure A8. Raw output of *SLAMcode.nb* for earthquake A5 on 15 January 1998. Small square marks the epicenter at latitude 39.44810°N longitude $120.15511^{\circ}\text{W}$. Nodal plane dip direction is 290° , dip angle 35° , rake 30° . Hypocenter depth was 4.636 km. The curves indicate the extent of the seismo-lineament. The image is aligned with the UTM grid, so the image would have to be rotated $\sim 1.73^{\circ}$ clockwise to be aligned with the geographic coordinate system at/near its center. North is toward the top of the page.

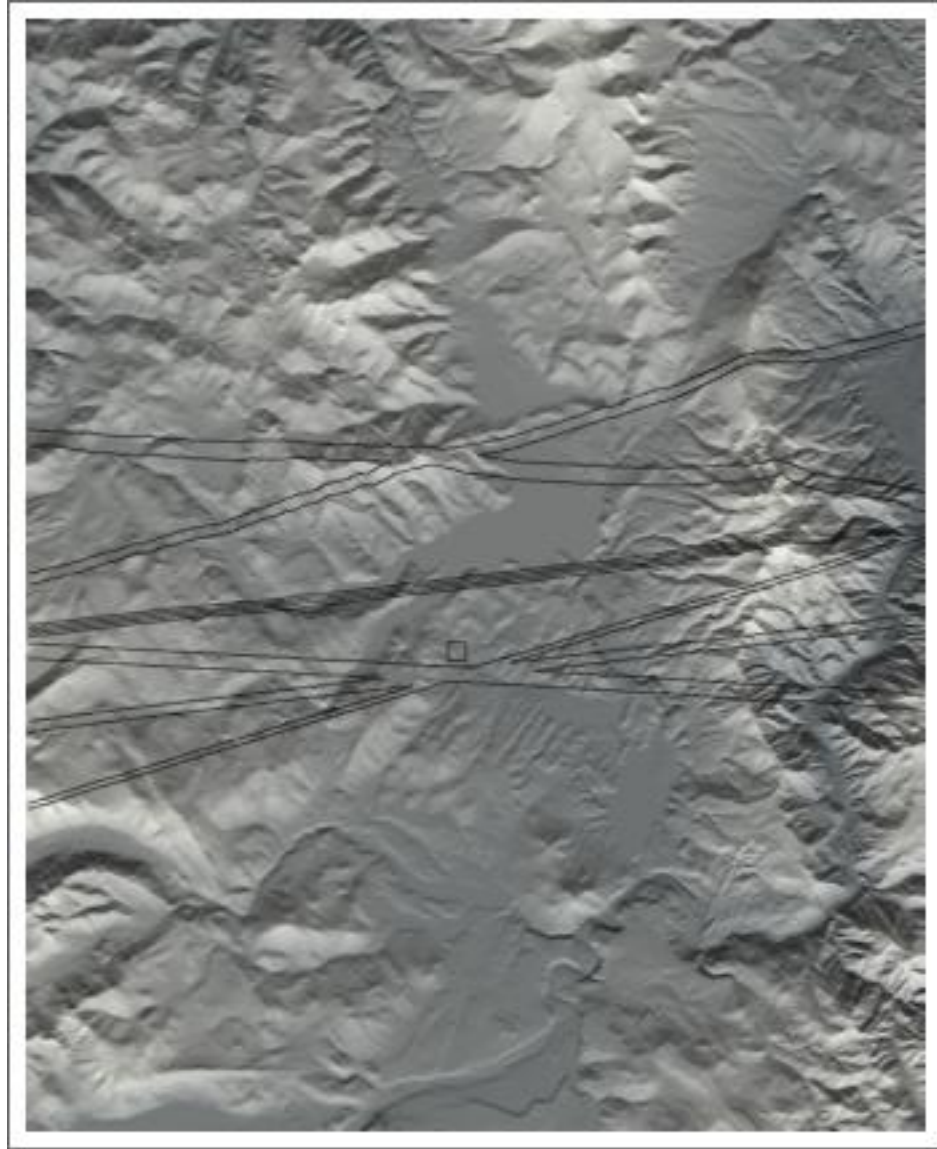
Figure A9. Raw output of *SLAMcode.nb* for earthquake A5 on 15 January 1998. Small square marks the epicenter at latitude 39.44810°N longitude $120.15511^{\circ}\text{W}$. Nodal plane dip direction is 175° , dip angle 73° , rake 121° . Hypocenter depth was 4.636 km. The curves indicate the extent of the seismo-lineament. The image is aligned with the UTM grid, so the image would have to be rotated $\sim 1.73^{\circ}$ clockwise to be aligned with the geographic coordinate system at/near its center. North is toward the top of the page.

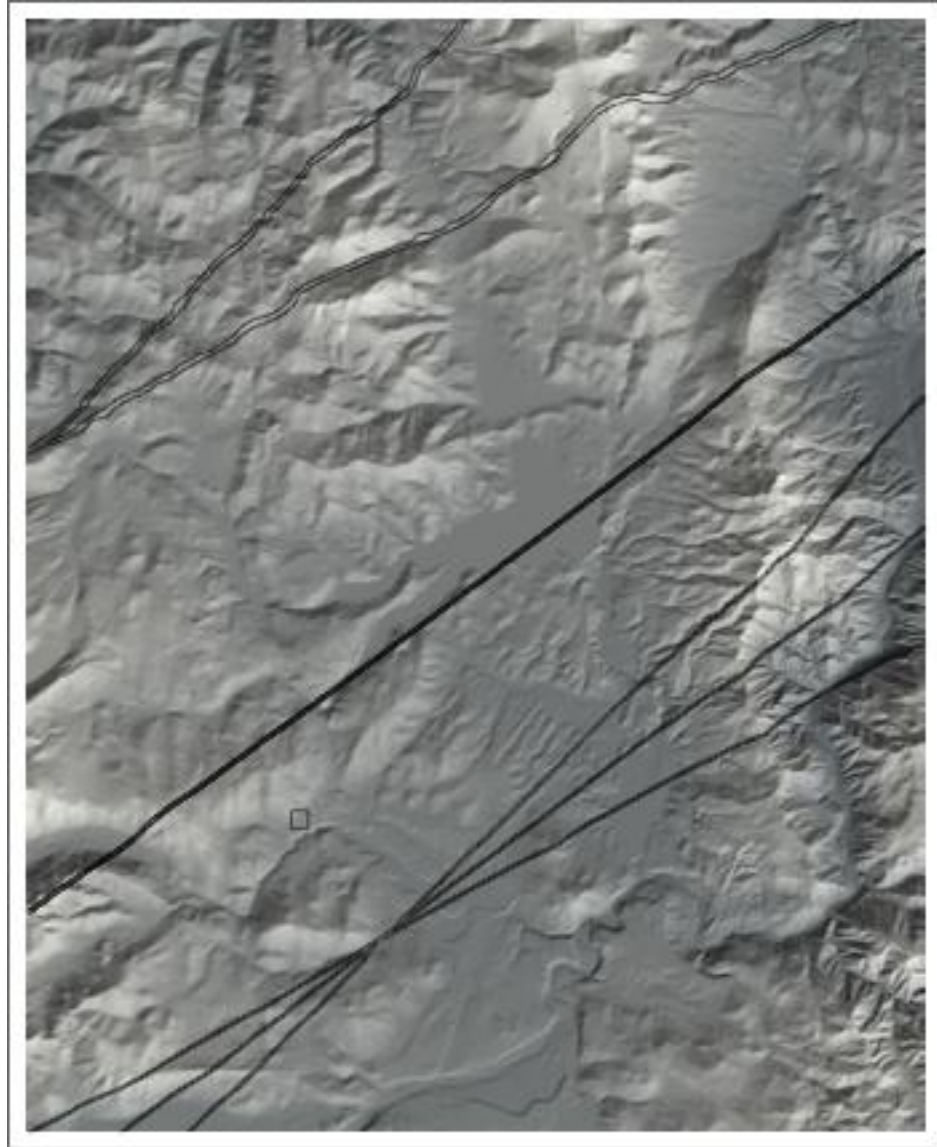
Figure A10. Raw output of *SLAMcode.nb* for earthquake A8 on 12 June 2004 at 14 hours 49 minutes. Small square marks the epicenter at latitude 39.40479°N longitude 120.21070°W. Nodal plane dip direction is 145°, dip angle 75°, rake -20°. Hypocenter depth was 7.292 km. The curves indicate the extent of the seismo-lineament. The image is aligned with the UTM grid, so the image would have to be rotated ~1.73° clockwise to be aligned with the geographic coordinate system at/near its center. North is toward the top of the page.

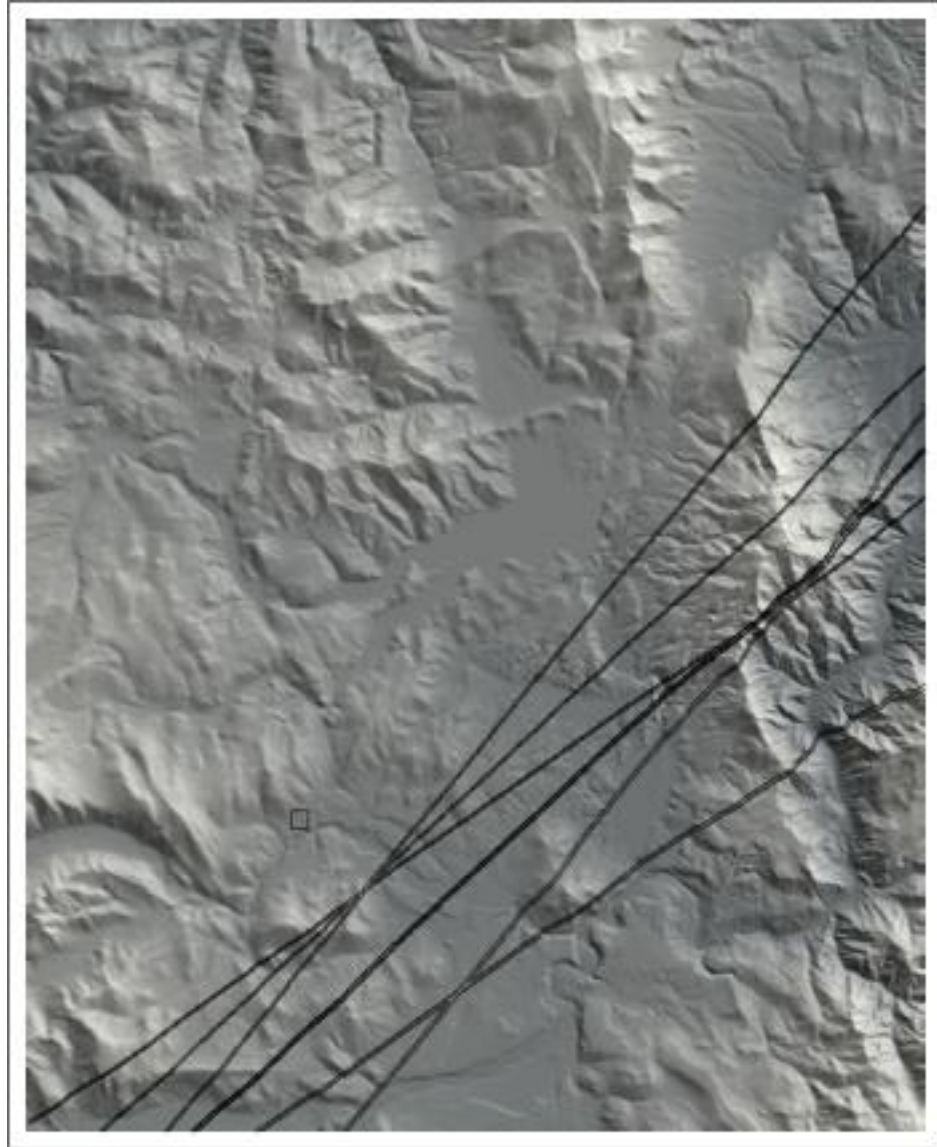
Figure A11. Raw output of *SLAMcode.nb* for earthquake A8 on 12 June 2004 at 14 hours 49 minutes. Small square marks the epicenter at latitude 39.40479°N longitude 120.21070°W. Nodal plane dip direction is 319°, dip angle 63°, rake -53°. Hypocenter depth was 7.292 km. The curves indicate the extent of the seismo-lineament. The image is aligned with the UTM grid, so the image would have to be rotated $\sim 1.73^\circ$ clockwise to be aligned with the geographic coordinate system at/near its center. North is toward the top of the page.

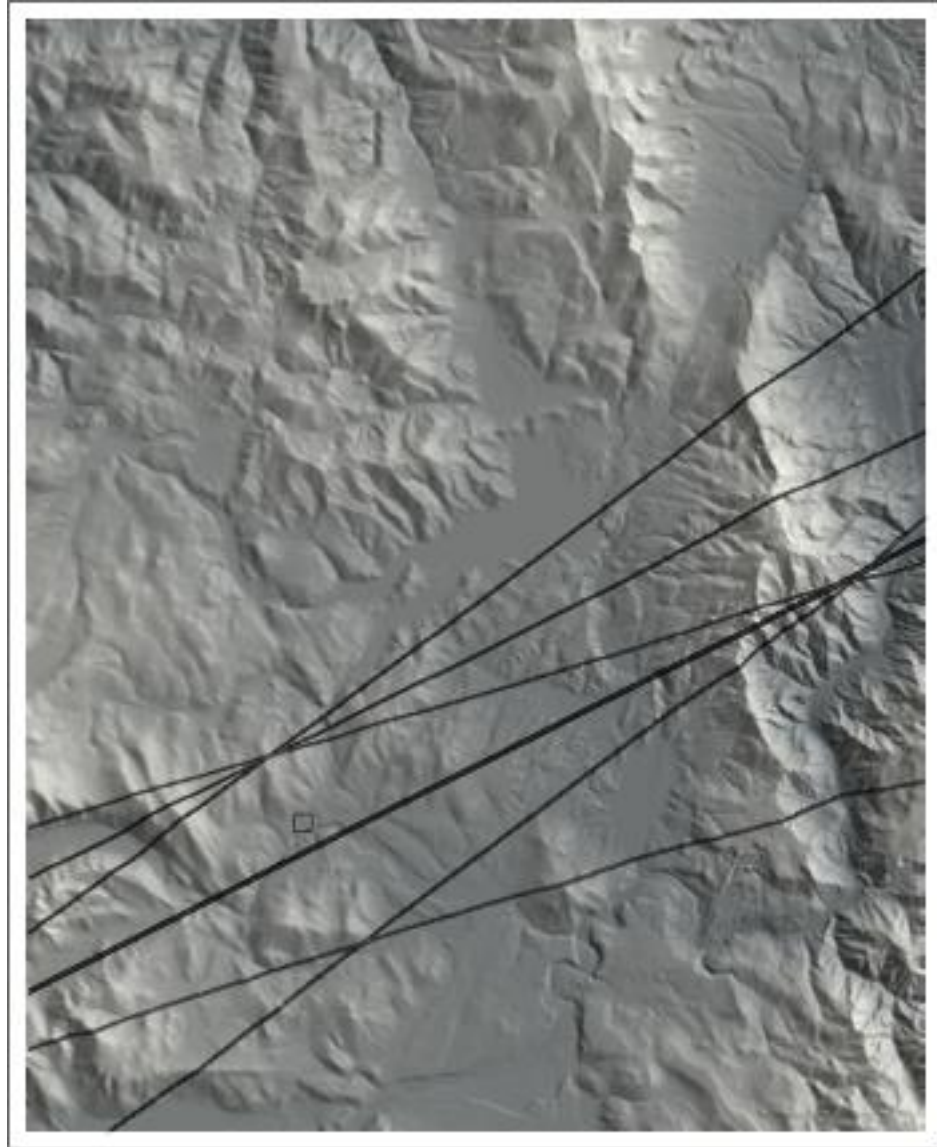
Figure A12. Raw output of *SLAMcode.nb* for earthquake A9 on 12 June 2004 at 15 hours 4 minutes. Small square marks the epicenter at latitude 39.40392°N longitude $120.20964^{\circ}\text{W}$. Nodal plane dip direction is 335° , dip angle 85° , rake 40° . Hypocenter depth was 7.350 km. The curves indicate the extent of the seismo-lineament. The image is aligned with the UTM grid, so the image would have to be rotated $\sim 1.73^{\circ}$ clockwise to be aligned with the geographic coordinate system at/near its center. North is toward the top of the page.

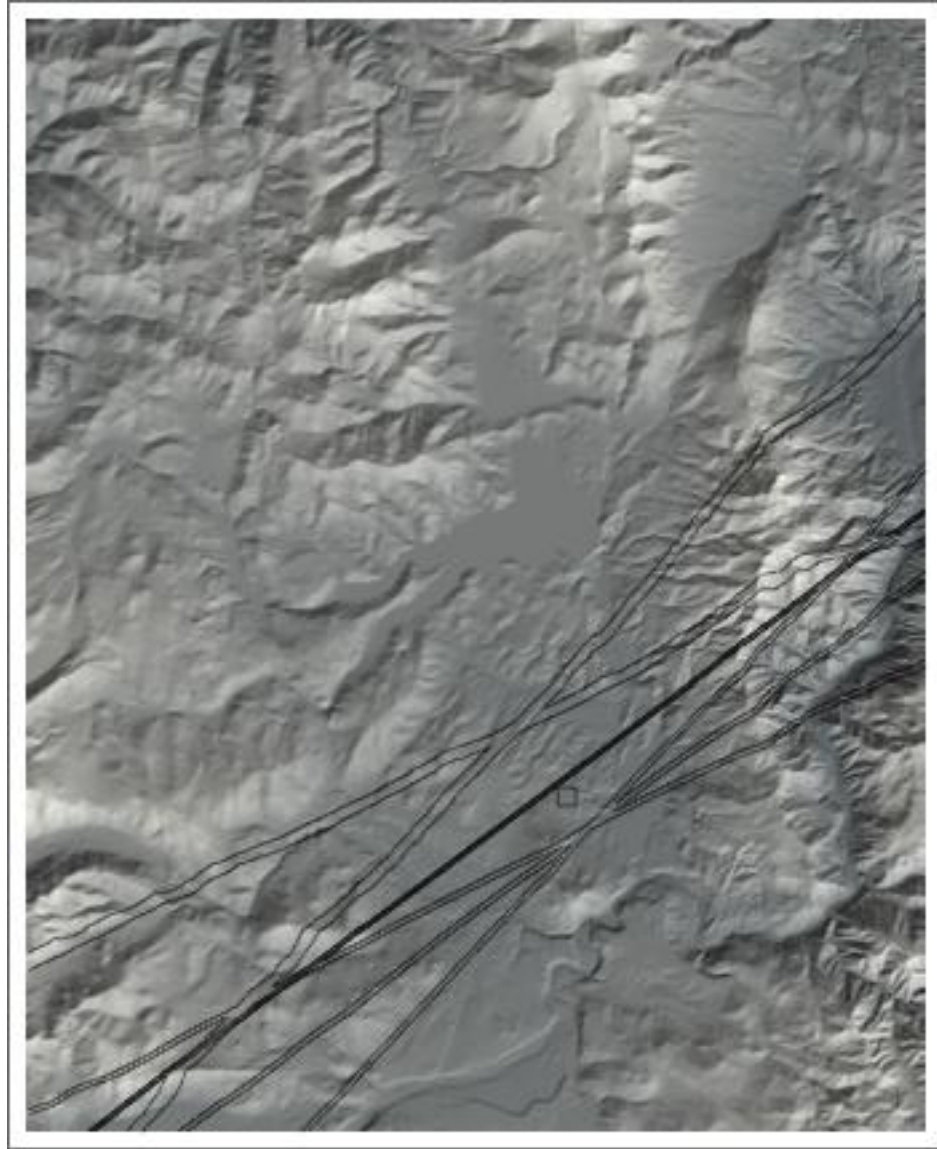
Figure A13. Raw output of *SLAMcode.nb* for earthquake A12 on 23 December 2011. Small square marks the epicenter at latitude 39.40871°N longitude $120.11916^{\circ}\text{W}$. Nodal plane dip direction is 145° , dip angle 80° , rake 0° . Hypocenter depth was 0.882 km. The curves indicate the extent of the seismo-lineament. The image is aligned with the UTM grid, so the image would have to be rotated $\sim 1.73^{\circ}$ clockwise to be aligned with the geographic coordinate system at/near its center. North is toward the top of the page.
