# Richard H. Jahns Lecture Series 2022-23

Vince Cronin

**Debris flows of February 5,  
1978, along Interstate 5  
near Grapevine, California**

**Debris flow of January 4,  
1982, along Oddstad Blvd  
in Pacifica, California**

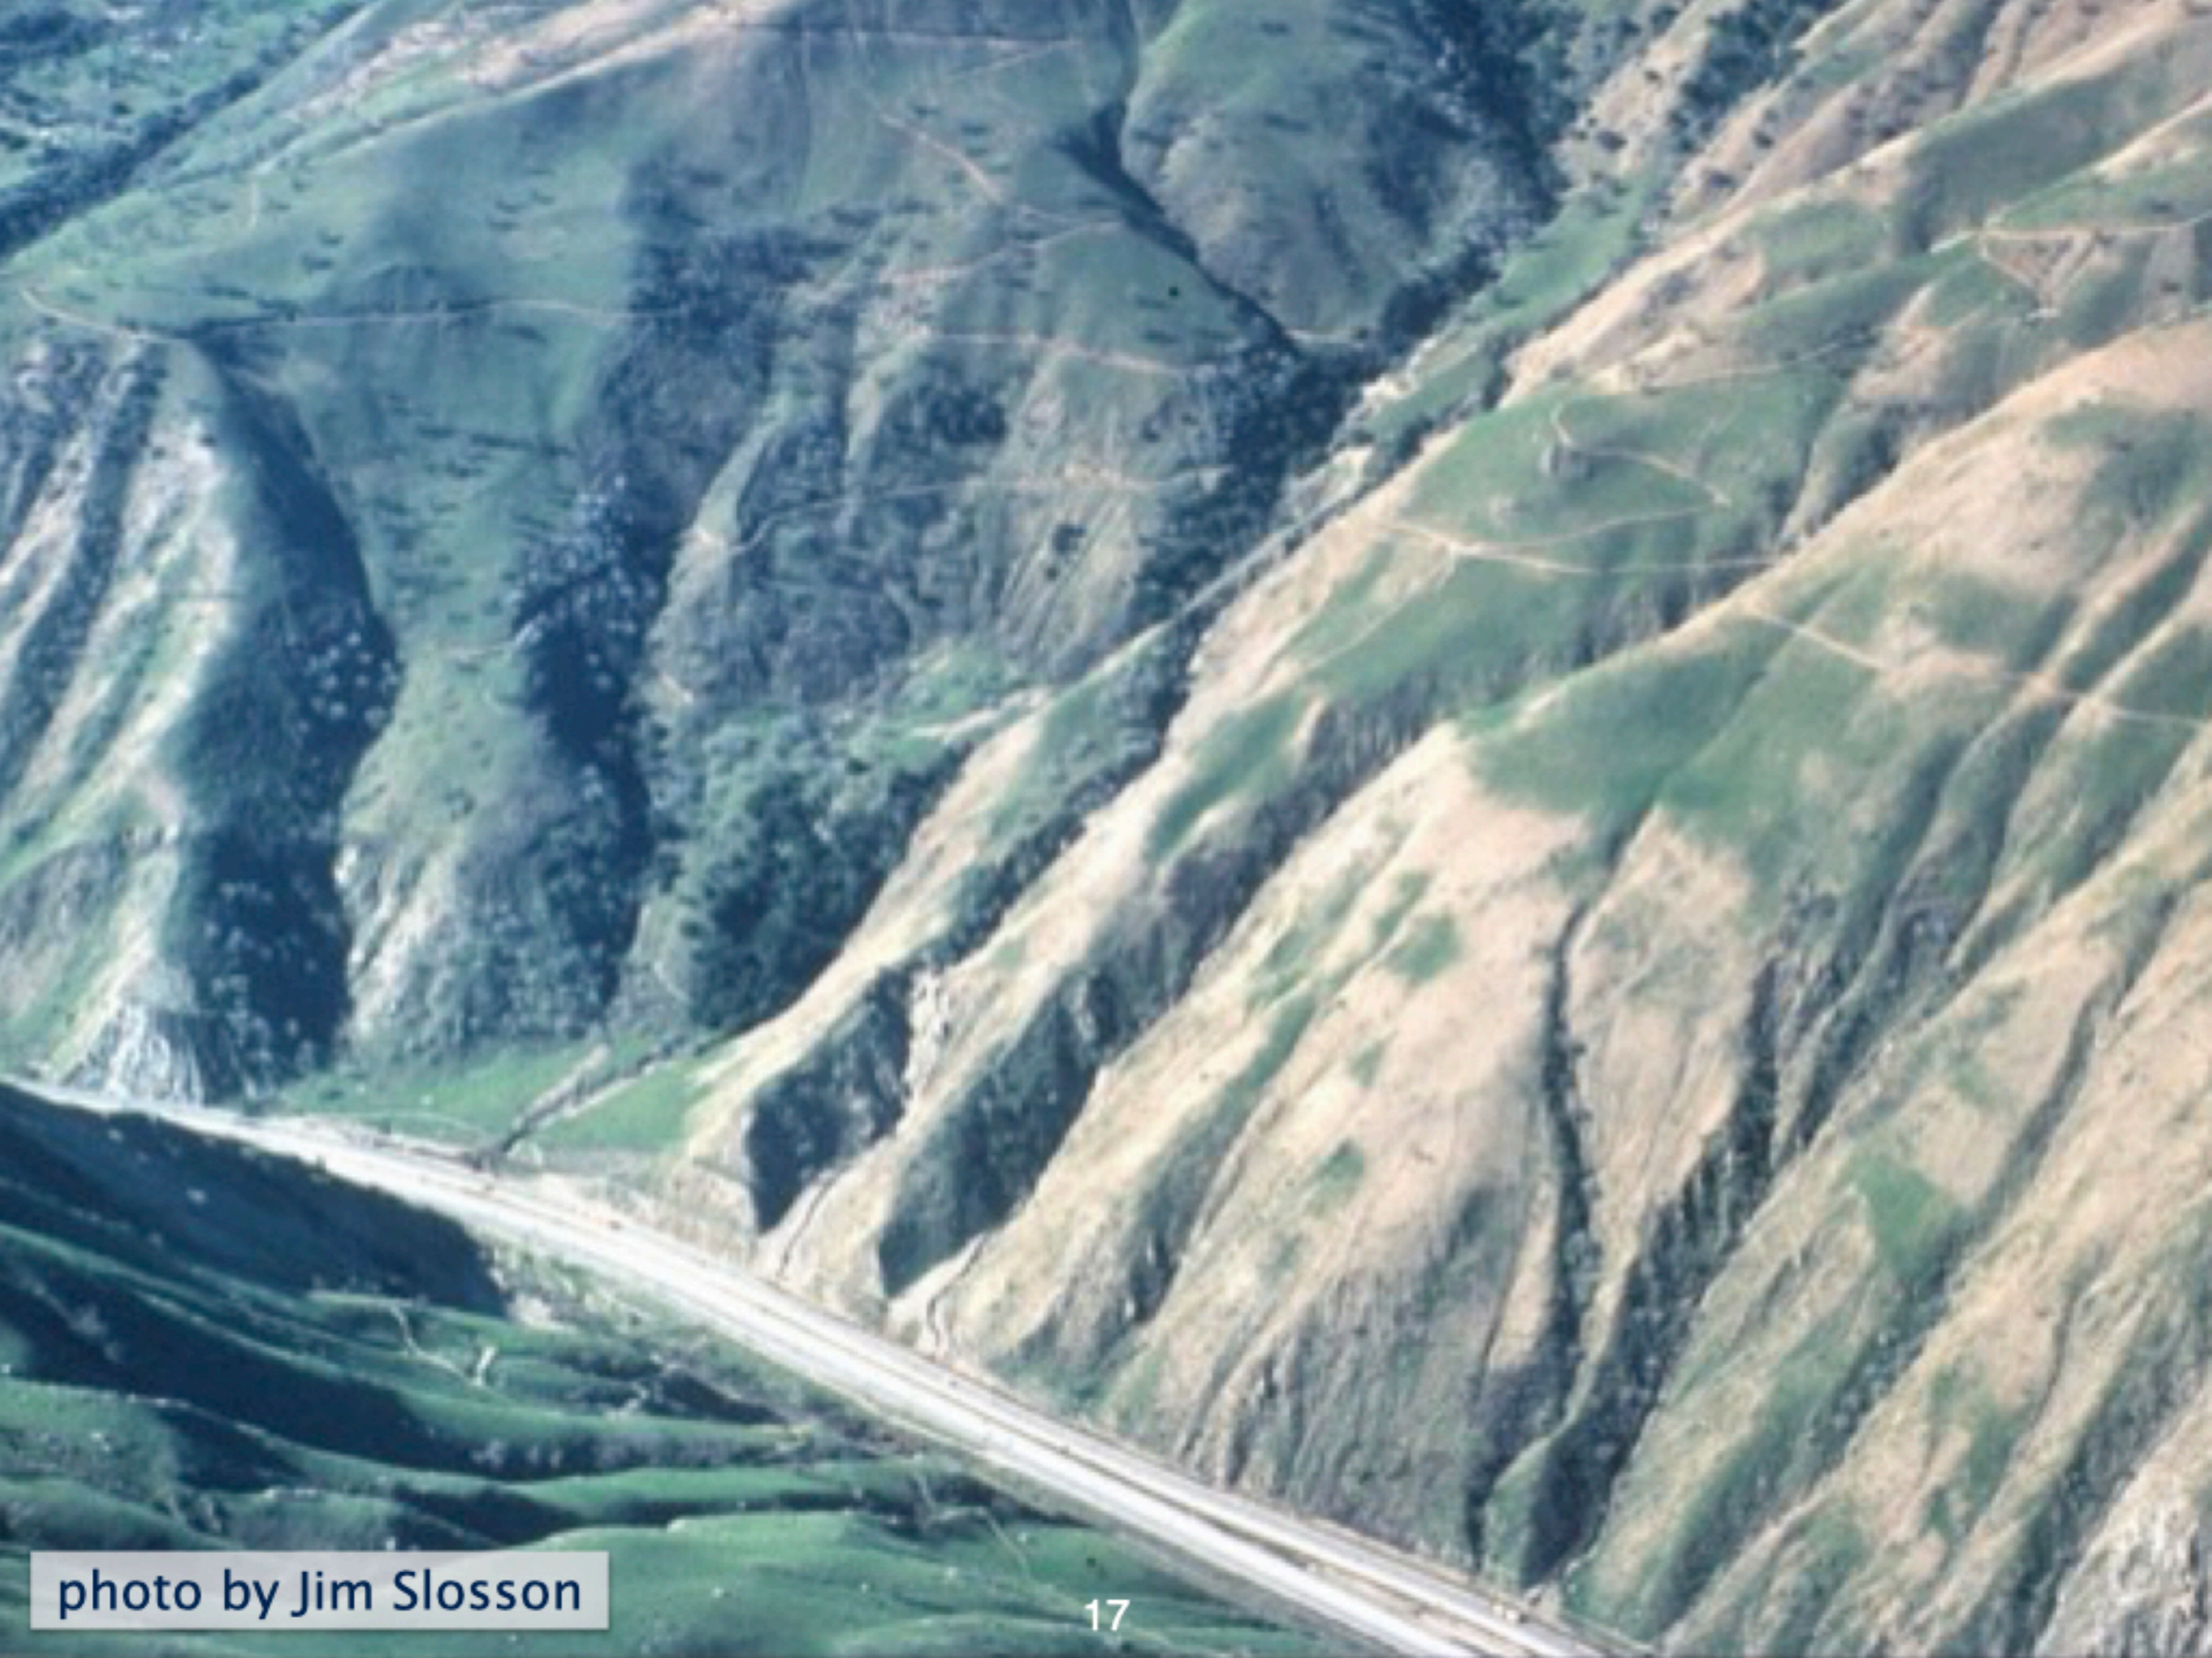
Most of the material in the 1978 debris flows had been stored in pre-existing drainage channels and channel walls.

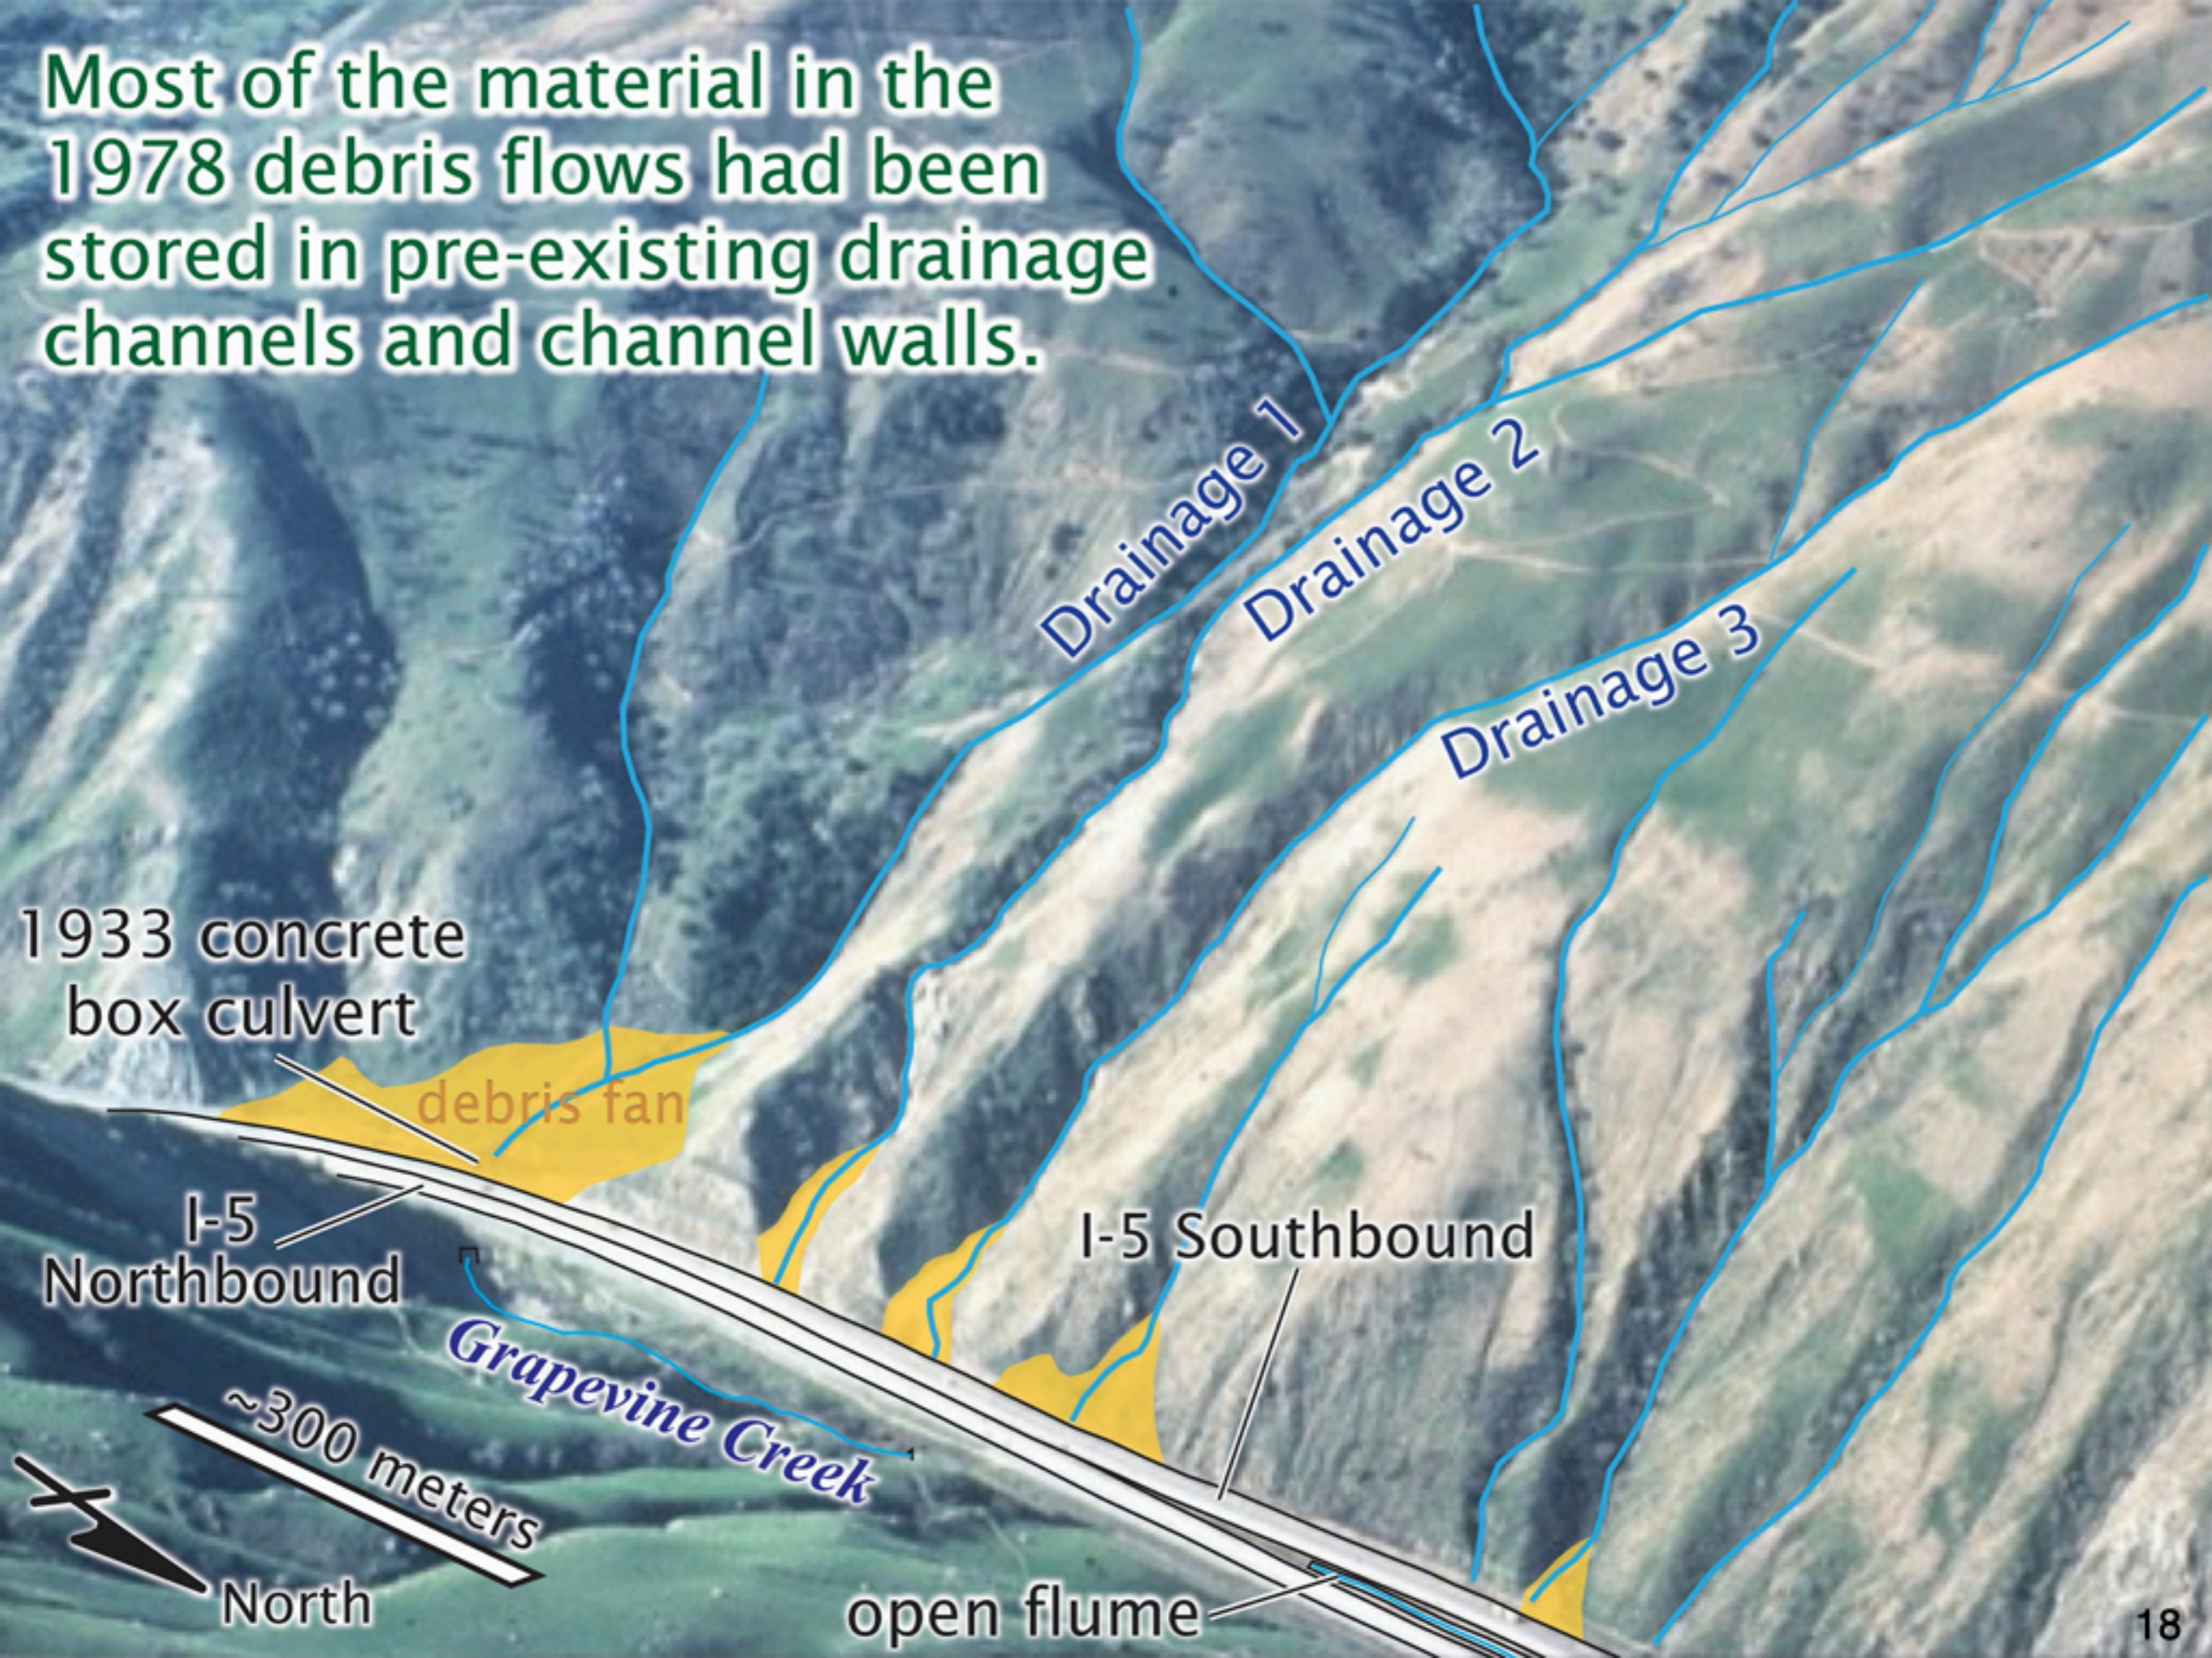
Drainage 1

Drainage 2

Drainage 3

1933 concrete box culvert

debris fan

open flume

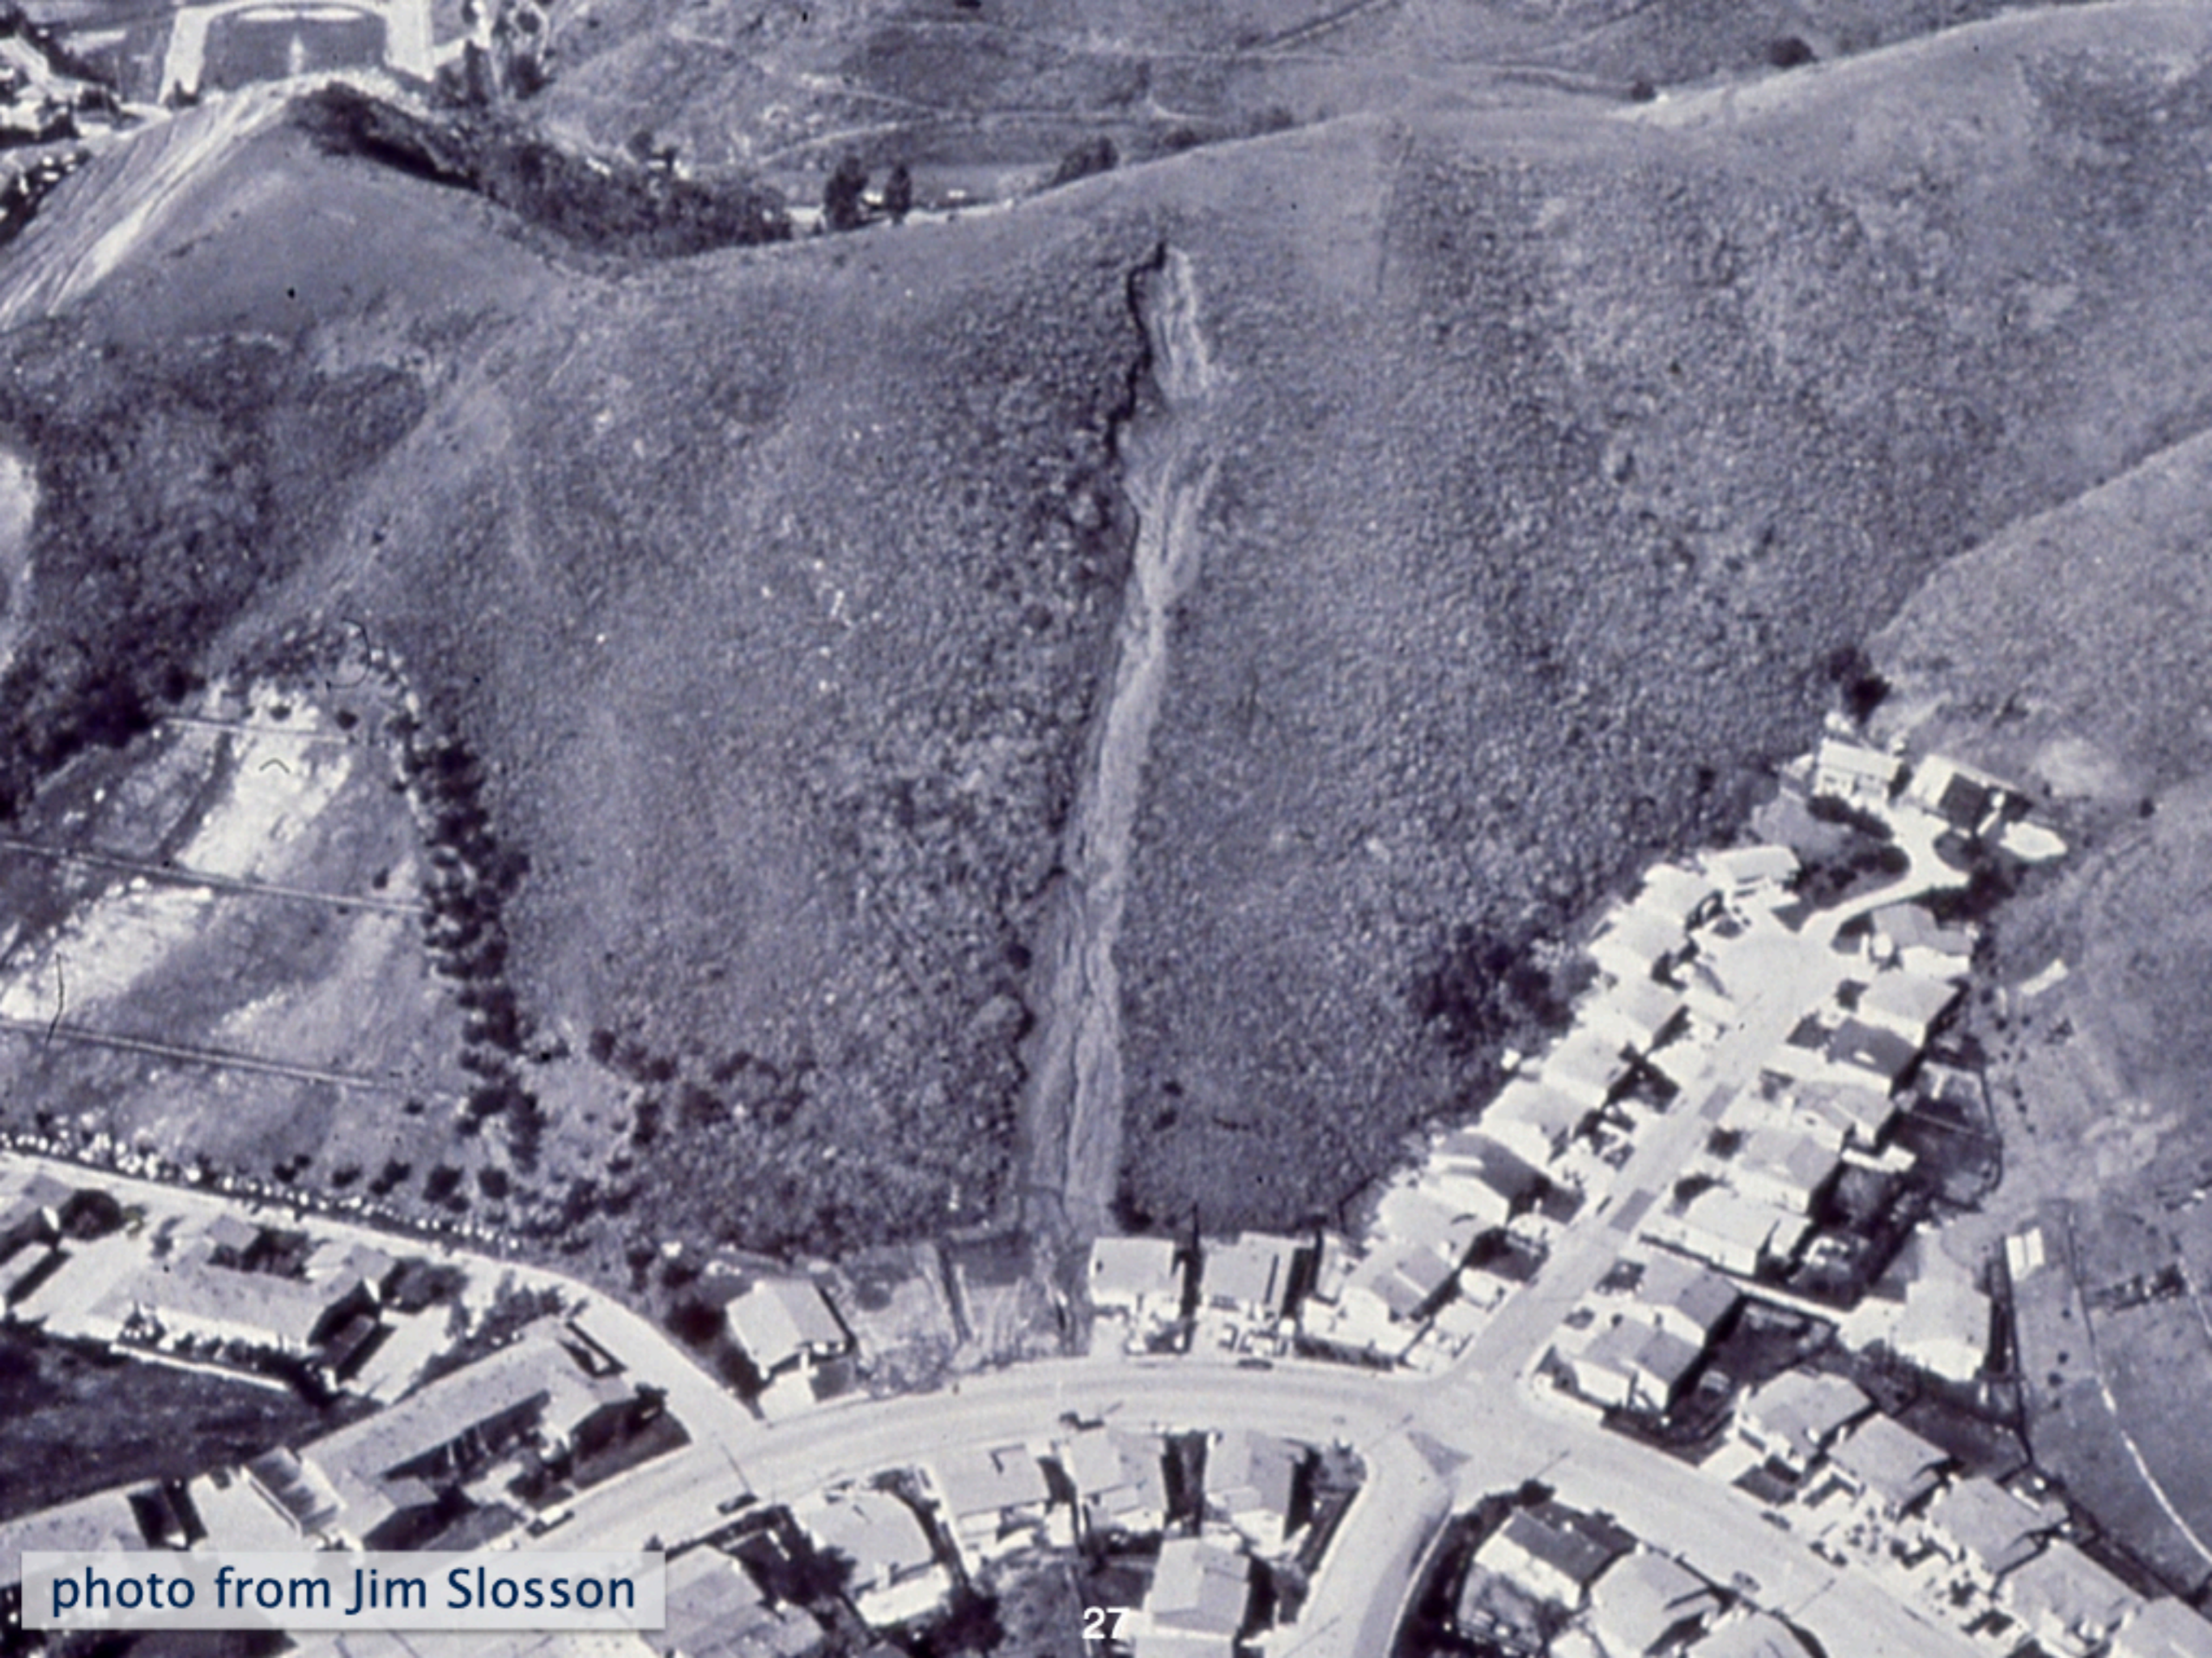
**Steep hill ~280 ft  
high behind the  
houses**

**Velez house**

*debris flow track*

**Neighboring house  
pushed into Velez house**

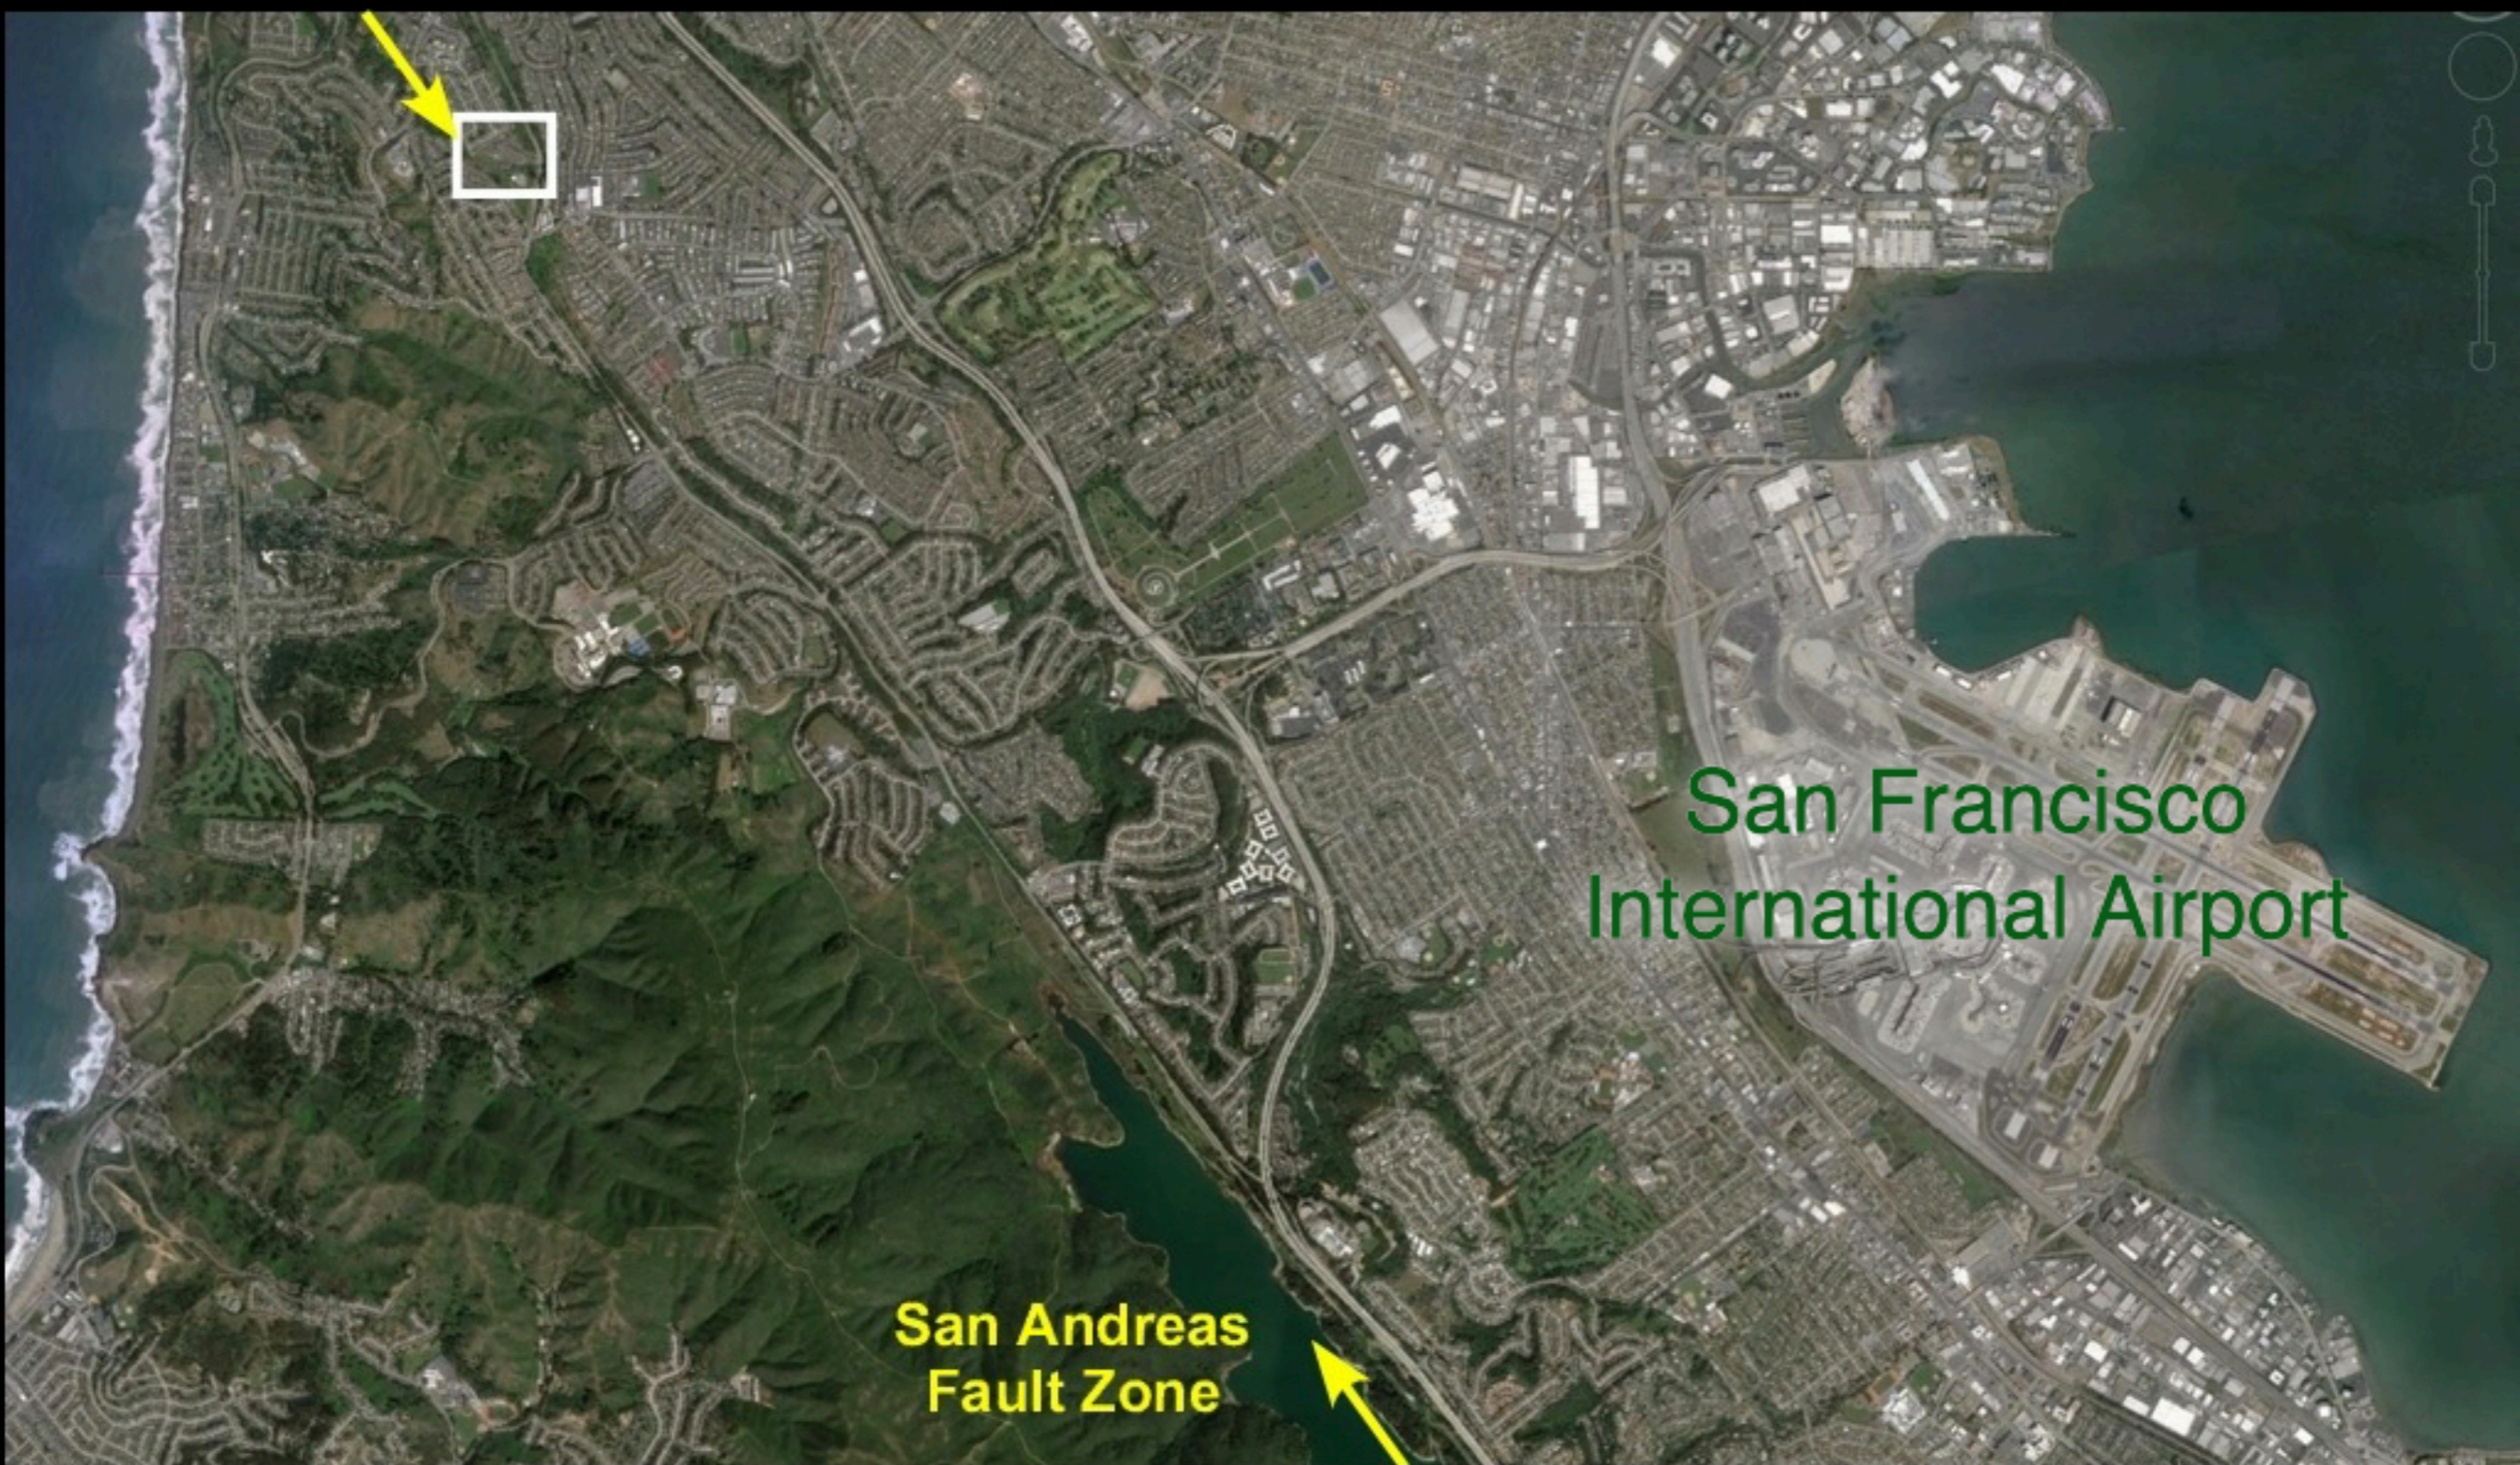
San Francisco  
International Airport

San Andreas  
Fault Zone

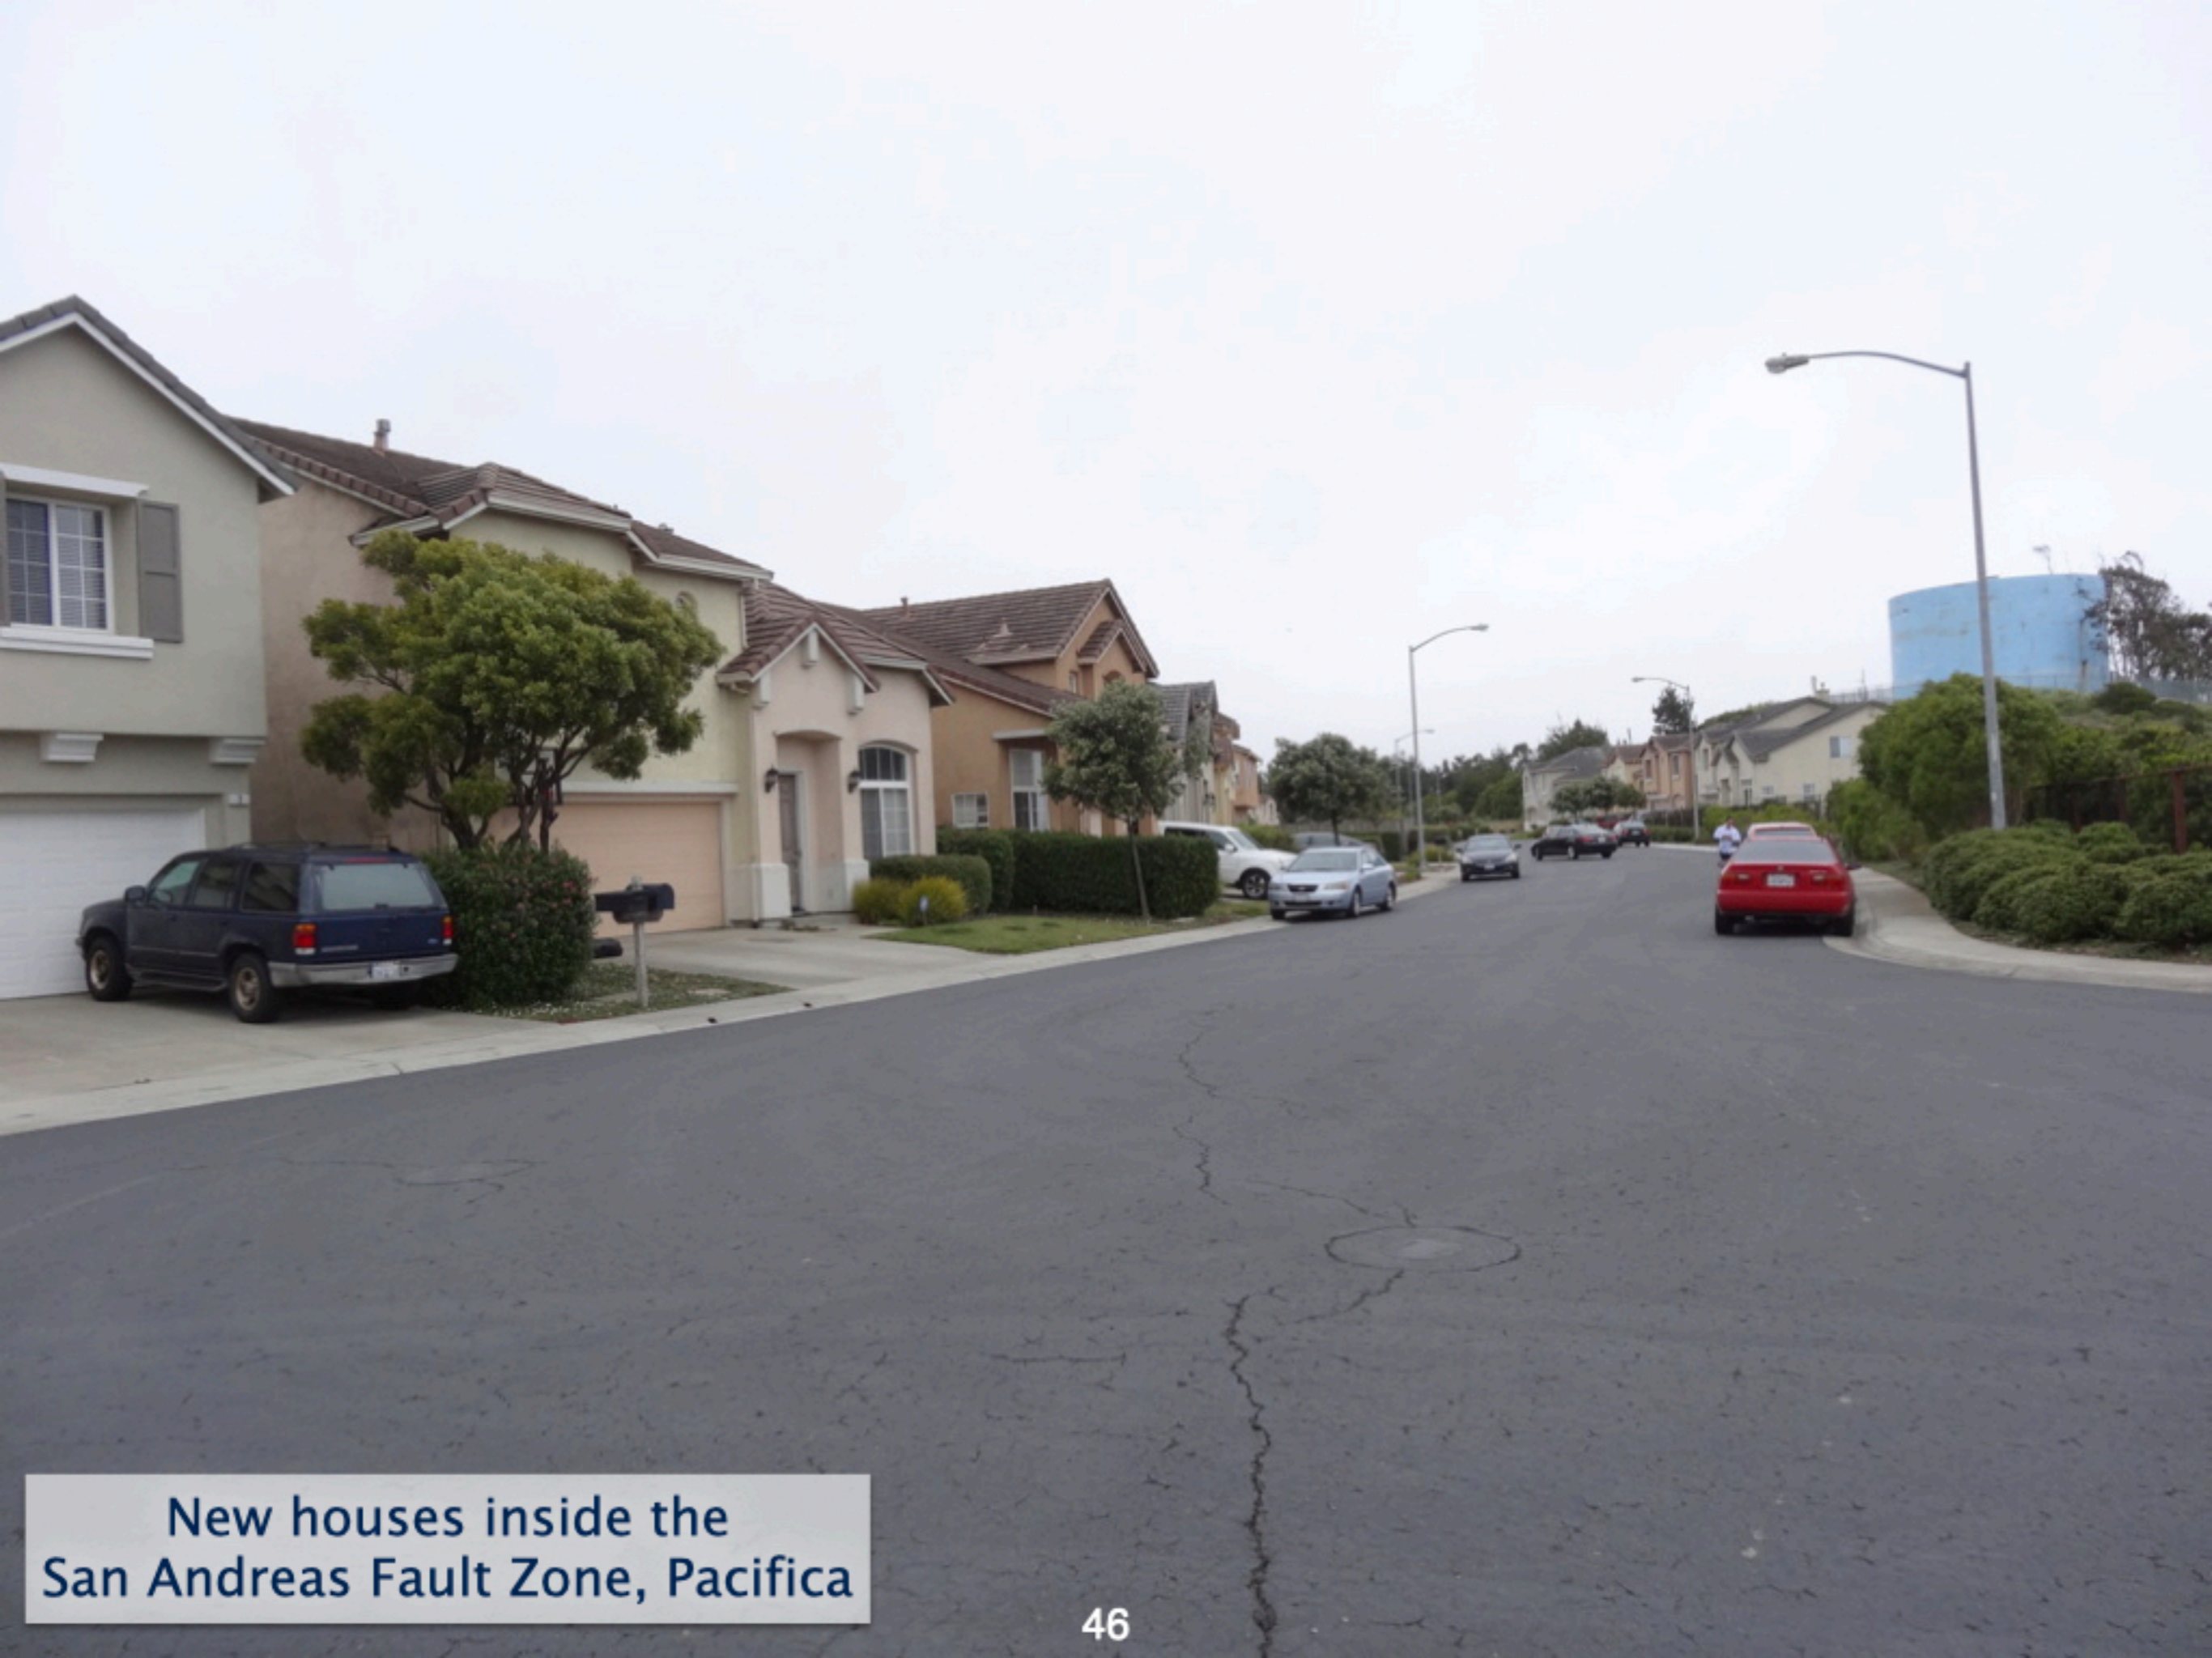
New houses inside the San Andreas Fault Zone, Pacifica
